# Access Compliance Report

## Public Rights-of-Way

### (Curb Ramps)

| Intersection ID: 17085 | Main Street: CROYDON_RD | Cross Street: SELWYN_AV | Location: NW |

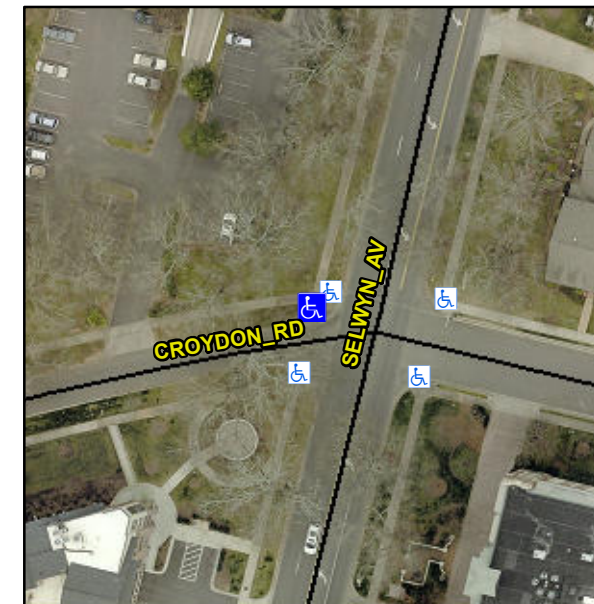
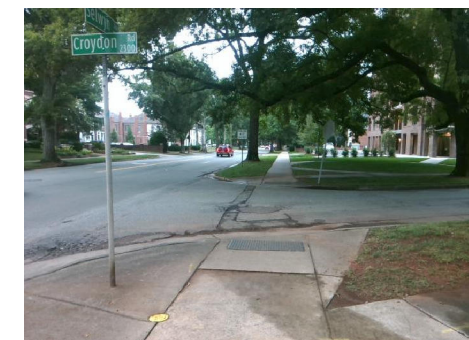
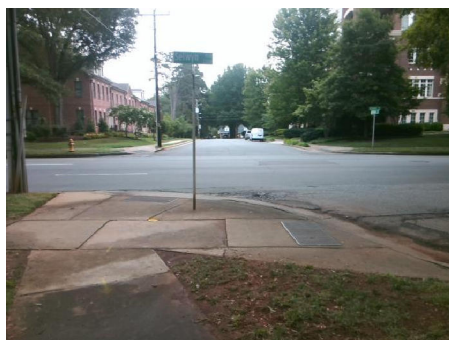
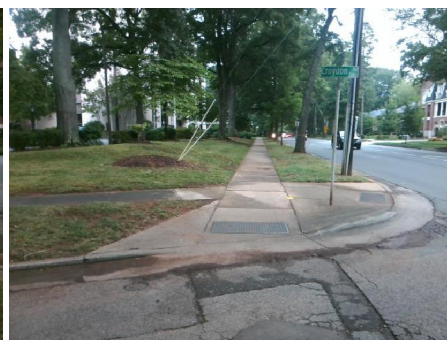
| Severity Score: 7.5 | | | |

| Compliance | Description | Data | Compliance | Description | Data |
|---|---|---|---|---|---|
| No | Landing Slope (%) | 2.3 | Yes | DWS Length (in) | 24.5 |
| Yes | Landing X Slope (%) | 1.5 | No | DWS Full Width? | No |
| N/A | Shared Landing? | No | No | DWS Offset RT (in) | 3.0 |
| No | Gutter Ponding? | Yes | No | Gutter Slope (%) | 7.5 |

**Remove & Replace Entire Ramp.  
Remove & Replace Gutter.**

Total Cost: \$ 2350.00
