# Access Compliance Report

## Public Rights-of-Way

### (Curb Ramps)

Intersection ID: 29158	Main Street: RIDGE_RD	Cross Street: HIGHLAND_PARK_DR	Location: N
ADA ID: 2B2F2AE782C0	Ramp Type: Perp	Initial Pass/Fail: Fail	Overall Compliance: No
			Severity Score: 21.25

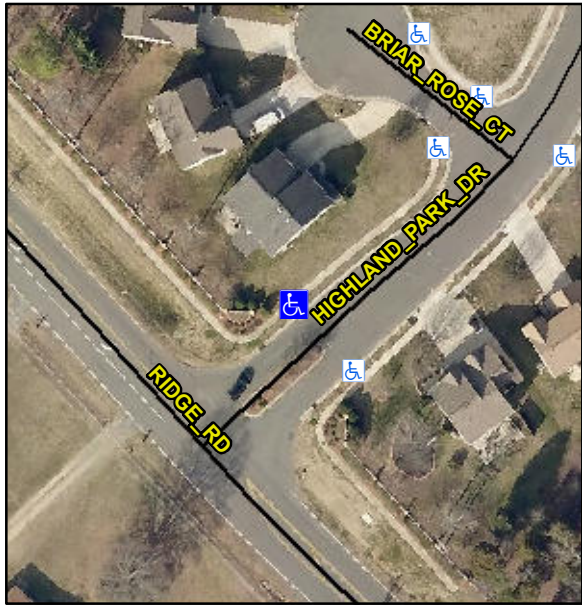
Possible Solutions:		Compliance	Description	Data	Compliance	Description	Data
	Remove & Replace Entire Ramp.		N/A	Ramp Length (in)	49.0	No	Ramp Slope (%)	9.2
			No	Ramp Width (in)	47.5	Yes	Ramp XSlope (%)	1.9
			N/A	Flare Type LT	N/A	N/A	Flare Type RT	N/A
			N/A	Flare Slope LT (%)	N/A	N/A	Flare Slope RT (%)	N/A
			N/A	Flare Traversable LT?	N/A	N/A	Flare Traversable RT?	N/A
			N/A	Landing Length (in)	N/A	N/A	DWS Provided?	N/A
			N/A	Landing Width (in)	N/A	N/A	DWS Contrast?	N/A
			N/A	Landing Slope (%)	N/A	N/A	DWS Length (in)	N/A
			N/A	Landing X Slope (%)	N/A	N/A	DWS Full Width?	N/A
Surveyor Notes:			N/A	Landing Curb? (Y/N)	N/A	N/A	DWS Offset (in)	N/A
N/A			N/A	Shared Landing?	N/A			
PROW/ADA:			N/A	Gutter Ponding?	N/A	N/A	Gutter Slope (%)	N/A
R304.5.1, R304.2.2			N/A	Gutter Lip Ht (in)	N/A	N/A	Gutter X Slope (%)	N/A

N/A	Painted X Walk1?	No	N/A	Painted X Walk2?	N/A
				X Walk 1 Direction	To SE		X Walk 2 Direction	N/A
			N/A	X Walk 1 Width (in)	N/A	N/A	X Walk 2 Width (in)	N/A
				X Walk 1 Slope (%)	2.9		X Walk 2 Slope (%)	N/A
				X Walk 1 X Slope (%)	1.2		X Walk 2 X Slope (%)	N/A
			N/A	Ramp inside XWalk1?	N/A	N/A	Ramp inside XWalk2?	N/A
				Road Slope (%)	N/A	N/A	Clear Space?	N/A
				Road X Slope (%)	N/A	N/A	Clear Space to XWalk (in)	N/A
			N/A	Any Obstructions?	N/A	N/A	Storm Grate/Utility Hazard?	N/A
				Obstruction Type			Storm Grate/Utility Type	
					N/A			N/A
						Yes	Surface Condition? (G/P)	Good
					</
