# Access Compliance Report

## Public Rights-of-Way

### (Curb Ramps)

Intersection ID: 12761	Main Street: S_MINT_ST	Cross Street: W_CARSON_BV	Location: N
ADA ID: 2B322F5229EC	Ramp Type: PerpDiag	Initial Pass/Fail: Fail	Overall Compliance: No
			Severity Score: 26.25

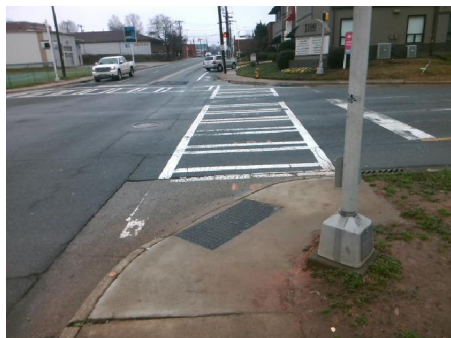
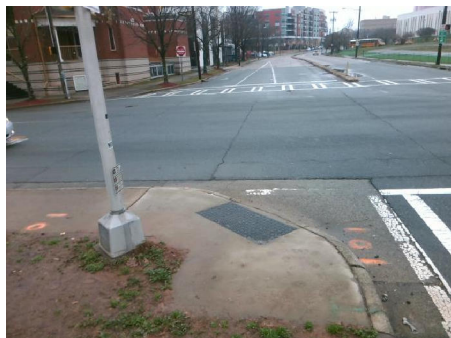
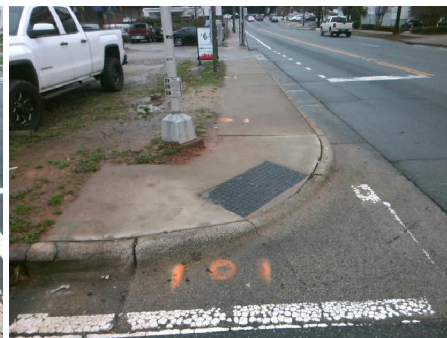
**Not Found, R304.2.2, R304.5.3**

Compliance	Description	Data	Compliance	Description	Data
N/A	Ramp Length (in)	55.0	No	Ramp Slope (%)	12.9
Yes	Ramp Width (in)	48.0	No	Ramp XSlope (%)	2.9
N/A	Flare Type LT	N/A	N/A	Flare Type RT	N/A
N/A	Flare Slope LT (%)	N/A	N/A	Flare Slope RT (%)	N/A
N/A	Flare Traversable LT?	N/A	N/A	Flare Traversable RT?	N/A
N/A	Landing Length (in)	N/A	N/A	DWS Provided?	N/A
N/A	Landing Width (in)	N/A	N/A	DWS Contrast?	N/A
N/A	Landing Slope (%)	N/A	N/A	DWS Length (in)	N/A
N/A	Landing X Slope (%)	N/A	N/A	DWS Full Width?	N/A
N/A	Landing Curb? (Y/N)	N/A	N/A	DWS Offset (in)	N/A
N/A	Shared Landing?	N/A			
N/A	Gutter Ponding?	N/A	N/A	Gutter Slope (%)	N/A
N/A	Gutter Lip Ht (in)	N/A	N/A	Gutter X Slope (%)	N/A
N/A	Painted X Walk1?	Yes	N/A	Painted X Walk2?	No
	X Walk 1 Direction	To SW		X Walk 2 Direction	To SE
N/A	X Walk 1 Width (in)	100.0	N/A	X Walk 2 Width (in)	N/A
	X Walk 1 Slope (%)	3.0		X Walk 2 Slope (%)	0.8
	X Walk 1 X Slope (%)	0.2		X Walk 2 X Slope (%)	2.4

N/A	Ramp inside XWalk1?	Yes	N/A	Ramp inside XWalk2?	N/A
	Road Slope (%)	1.7	N/A	Clear Space?	N/A
	Road X Slope (%)	0.0	N/A	Clear Space to XWalk (in)	N/A
N/A	Any Obstructions?	N/A	N/A	Storm Grate/Utility Hazard?	N/A
	Obstruction Type			Storm Grate/Utility Type	
		N/A			N/A
			Yes	Surface Condition? (G/P)	Good

**Remove & Replace Curb Ramp With Two New Directional Ramps or Equivalent.**
