Access Compliance Report

Public Rights-of-Way

(Curb Ramps)

Intersection ID: 14251	Main Street: CHESTERFIELD_AV	Cross Street: LORNA_ST	Location: E
ADA ID: 2B32AAA5F576	Ramp Type: Perp	Initial Pass/Fail: Fail	Overall Compliance: No
		Severity Score: 12.5

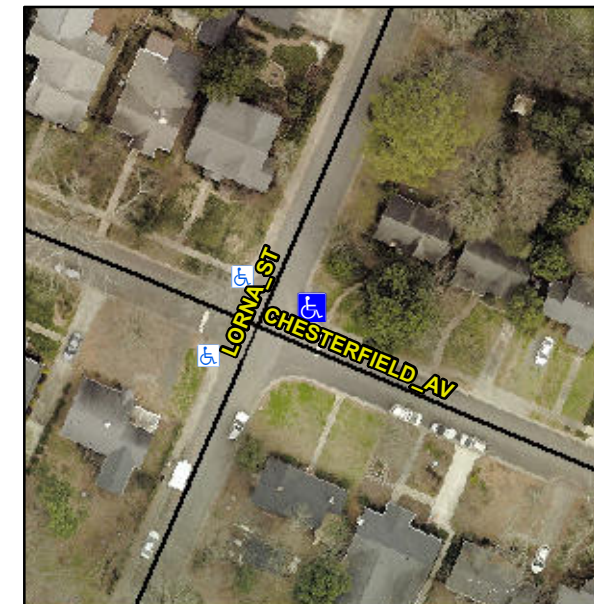
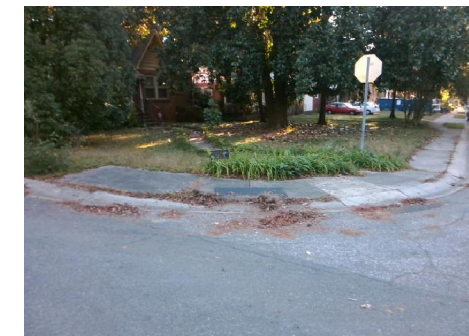
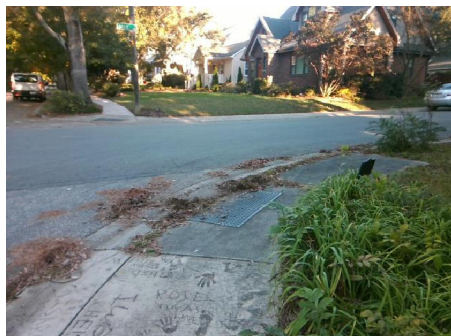
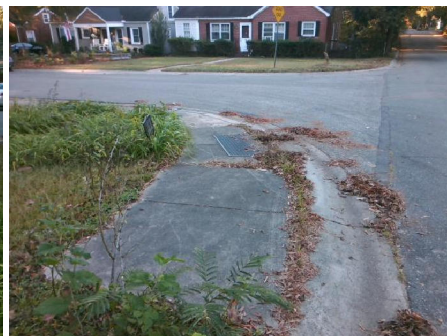
R304.5.3

Compliance	Description	Data	Compliance	Description	Data
N/A	Ramp Length (in)	56.0	Yes	Ramp Slope (%)	5.2
Yes	Ramp Width (in)	62.0	No	Ramp XSlope (%)	6.2
N/A	Flare Type LT	N/A	N/A	Flare Type RT	N/A
N/A	Flare Slope LT (%)	N/A	N/A	Flare Slope RT (%)	N/A
N/A	Flare Traversable LT?	N/A	N/A	Flare Traversable RT?	N/A
N/A	Landing Length (in)	N/A	N/A	DWS Provided?	N/A
N/A	Landing Width (in)	N/A	N/A	DWS Contrast?	N/A
N/A	Landing Slope (%)	N/A	N/A	DWS Length (in)	N/A
N/A	Landing X Slope (%)	N/A	N/A	DWS Full Width?	N/A
N/A	Landing Curb? (Y/N)	N/A	N/A	DWS Offset (in)	N/A
N/A	Shared Landing?	N/A			
N/A	Gutter Ponding?	N/A	N/A	Gutter Slope (%)	N/A
N/A	Gutter Lip Ht (in)	0.5	N/A	Gutter X Slope (%)	N/A
N/A	Painted X Walk1?	No	N/A	Painted X Walk2?	N/A
	X Walk 1 Direction	To NW		X Walk 2 Direction	N/A
N/A	X Walk 1 Width (in)	N/A	N/A	X Walk 2 Width (in)	N/A
	X Walk 1 Slope (%)	11.3		X Walk 2 Slope (%)	N/A
	X Walk 1 X Slope (%)	0.3		X Walk 2 X Slope (%)	N/A

N/A	Ramp inside XWalk1?	N/A	N/A	Ramp inside XWalk2?	N/A
	Road Slope (%)	N/A	N/A	Clear Space?	N/A
	Road X Slope (%)	N/A	N/A	Clear Space to XWalk (in)	N/A
N/A	Any Obstructions?	N/A	N/A	Storm Grate/Utility Hazard?	N/A
	Obstruction Type			Storm Grate/Utility Type	
		N/A			N/A
			Yes	Surface Condition? (G/P)	Good

Remove & Replace Entire Ramp.

\$ 1850.00
