# Access Compliance Report

## Public Rights-of-Way

### (Curb Ramps)

Intersection ID: 47838	Main Street: SPUR_RANCH_RD	Cross Street: ALVARADO_WY	Location: SE
ADA ID: 2B5077CF4B9F	Ramp Type: Perp	Initial Pass/Fail: Fail	Overall Compliance: No
Codes/Mitigation Info/Possible Solution		Field Measurements/Component Compliance	
Severity Score: 21.25

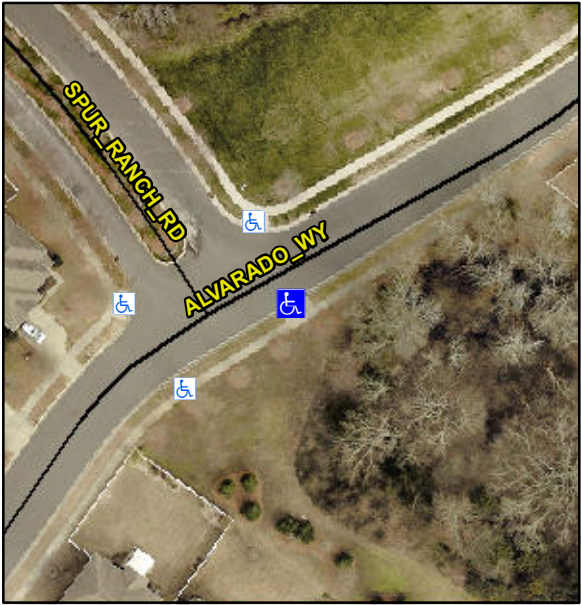
Possible Solutions:						
	Remove & Replace Entire Ramp.	N/A	Ramp Length (in)	74.0	No	Ramp Slope (%)	10.2
		No	Ramp Width (in)	46.0	Yes	Ramp XSlope (%)	1.9
		N/A	Flare Type LT	N/A	N/A	Flare Type RT	N/A
		N/A	Flare Slope LT (%)	N/A	N/A	Flare Slope RT (%)	N/A
		N/A	Flare Traversable LT?	N/A	N/A	Flare Traversable RT?	N/A
		N/A	Landing Length (in)	N/A	N/A	DWS Provided?	N/A
		N/A	Landing Width (in)	N/A	N/A	DWS Contrast?	N/A
		N/A	Landing Slope (%)	N/A	N/A	DWS Length (in)	N/A
		N/A	Landing X Slope (%)	N/A	N/A	DWS Full Width?	N/A
<p>Surveyor Notes:</p> <p>N/A</p> <p>PROW/ADA:</p> <p>Not Found, R304.5.1, R304.2.2</p>		N/A	Landing Curb? (Y/N)	N/A	N/A	DWS Offset (in)	N/A
		N/A	Shared Landing?	N/A			
		N/A	Gutter Ponding?	N/A	N/A	Gutter Slope (%)	N/A
		N/A	Gutter Lip Ht (in)	N/A	N/A	Gutter X Slope (%)	N/A
		N/A	Painted X Walk1?	No	N/A	Painted X Walk2?	N/A
			X Walk 1 Direction	To NW		X Walk 2 Direction	N/A
		N/A	X Walk 1 Width (in)	N/A	N/A	X Walk 2 Width (in)	N/A
