Access Compliance Report

Public Rights-of-Way

(Curb Ramps)

Intersection ID: 44293	Main Street: ANSEL_LN	Cross Street: ROCKWOOD_RD	Location: SE
ADA ID: 2B51AB3A7F11	Ramp Type: BlendTrans2	Initial Pass/Fail: Fail	Overall Compliance: No
			Severity Score: 21.25

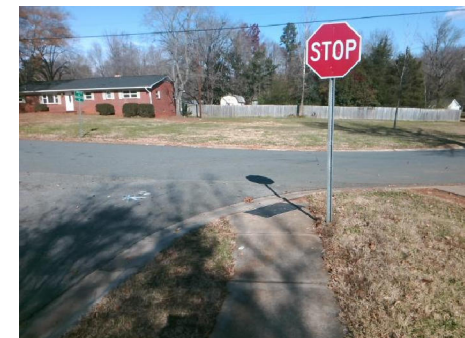
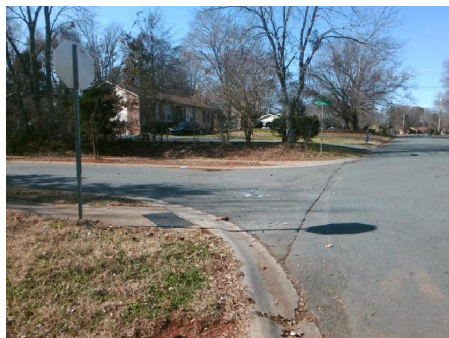
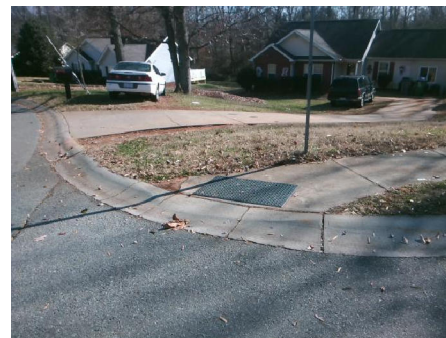
Not Found, R304.5.1, R304.5.3

Compliance	Description	Data	Compliance	Description	Data
N/A	Ramp Length (in)	57.5	Yes	BlendTrans Slope (%)	3.5
No	Ramp Width (in)	46.0	No	BlendTrans XSlope (%)	5.1
N/A	Flare Type LT	N/A	N/A	Flare Type RT	N/A
N/A	Flare Slope LT (%)	N/A	N/A	Flare Slope RT (%)	N/A
N/A	Flare Traversable LT?	N/A	N/A	Flare Traversable RT?	N/A
N/A	Landing Length (in)	N/A	N/A	DWS Provided?	N/A
N/A	Landing Width (in)	N/A	N/A	DWS Contrast?	N/A
N/A	Landing Slope (%)	N/A	N/A	DWS Length (in)	N/A
N/A	Landing X Slope (%)	N/A	N/A	DWS Full Width?	N/A
N/A	Landing Curb? (Y/N)	N/A	N/A	DWS Offset (in)	N/A
N/A	Shared Landing?	N/A			
N/A	Gutter Ponding?	N/A	N/A	Gutter Slope (%)	N/A
N/A	Gutter Lip Ht (in)	N/A	N/A	Gutter X Slope (%)	N/A
N/A	Painted X Walk1?	No	N/A	Painted X Walk2?	N/A
	X Walk 1 Direction	To W		X Walk 2 Direction	N/A
	X Walk 1 Width (in)	N/A		X Walk 2 Width (in)	N/A
	X Walk 1 Slope (%)	3.7		X Walk 2 Slope (%)	N/A
	X Walk 1 X Slope (%)	1.6		X Walk 2 X Slope (%)	N/A

N/A	Ramp inside XWalk1?	N/A	N/A	Ramp inside XWalk2?	N/A
	Road Slope (%)	1.6		Clear Space?	N/A
	Road X Slope (%)	3.7	N/A	Clear Space to XWalk (in)	N/A
N/A	Any Obstructions?	N/A	N/A	Storm Grate/Utility Hazard?	N/A
	Obstruction Type			Storm Grate/Utility Type	
		N/A			N/A
			Yes	Surface Condition? (G/P)	Good
			No	Curb Slope (%)	18.4

Remove & Replace Curb Ramp With Two New Directional Ramps or Equivalent.
