Access Compliance Report Public Rights-of-Way (Curb Ramps)

Intersection ID: 20051 Main Street: ARCHDALE_DR Cross Street: BURNLEY_RD Location: E

ADA ID: 2B52D44C1D28 Ramp Type: Combination2Diag Initial Pass/Fail: Fail Overall Compliance: No Severity Score: 0

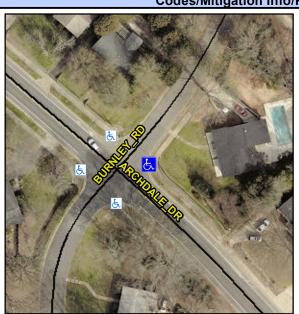
Not Found, R304.5.3, R304.3.2

N/A N/A Ramp Length LT (in) 45.5 Ramp Length RT (in) 72.0 N/A Yes Ramp Width LT (in) Ramp Width RT (in) 12.7 N/A No Ramp Slope LT (%) Ramp Slope RT (%) Ramp XSlope LT (%) 2.3 N/A Ramp XSlope RT (%) No N/A Ramp Length (in) 39.0 Yes Ramp Slope (%) 48.0 No Ramp XSlope (%) Yes Ramp Width (in) N/A Flare Type LT N/A N/A Flare Type RT N/A N/A Flare Slope LT (%) N/A Flare Slope RT (%) N/A Flare Traversable LT? N/A N/A Flare Traversable RT? N/A Landing Length (in) N/A N/A DWS Provided? N/A N/A **DWS Contrast?** N/A Landing Width (in) N/A Landing Slope (%) N/A N/A DWS Length (in) N/A Landing X Slope (%) N/A N/A DWS Full Width? N/A Landing Curb? (Y/N) N/A N/A DWS Offset (in) N/A Shared Landing? N/A N/A Gutter Ponding? N/A N/A Gutter Slope (%) N/A N/A Gutter Lip Ht (in) N/A Gutter X Slope (%) N/A N/A Painted X Walk1? No Painted X Walk2? To NW X Walk 1 Direction X Walk 2 Direction X Walk 1 Width (in) N/A X Walk 2 Width (in) 4.5 X Walk 1 Slope (%) X Walk 2 Slope (%) X Walk 1 X Slope (%) 4.1 X Walk 2 X Slope (%) N/A Ramp inside XWalk1? N/A N/A Ramp inside XWalk2?

Remove & Replace Curb Ramp With Two New Directional Ramps or Equivalent.
