# Access Compliance Report

## Public Rights-of-Way

### (Curb Ramps)

| Intersection ID: 12267 | Main Street: CENTRAL_AV | Cross Street: LOUISE_AV | Location: SW |

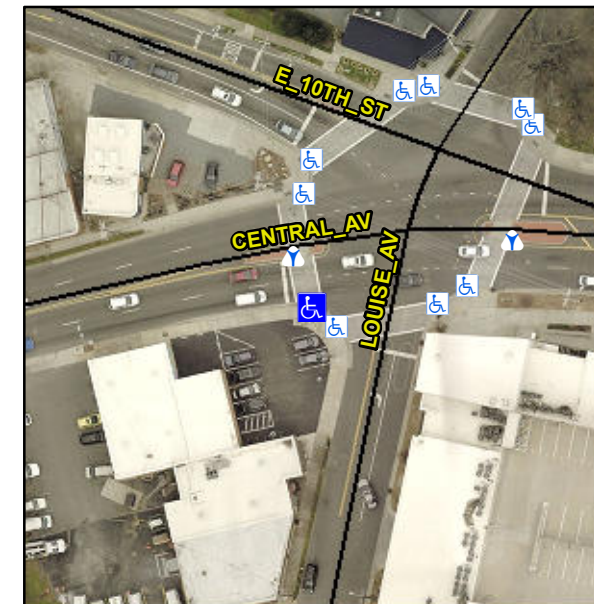
**R304.5.3, R304.2.1, R305.2, R304.5.4**

| Compliance | Description | Data | Compliance | Description | Data |
|---|---|---|---|---|---|
| Yes | Ramp XSlope LT (%) | 1.6 | No | Ramp XSlope RT (%) | 4.2 |
| No | Landing Width (in) | 45.0 | Yes | DWS Contrast? | Yes |
| N/A | Landing Curb? (Y/N) | No | No | DWS Offset (in) | 3.5 |
| Yes | Gutter Ponding? | No | No | Gutter Slope (%) | 5.8 |

**Remove & Replace Entire Ramp.  
Remove & Replace Gutter.**
