# Access Compliance Report

## Public Rights-of-Way

### (Curb Ramps)

| Intersection ID: 45782 | Main Street: BITTER_CREEK_DR | Cross Street: LONG_HILL_DR | Location: NE |

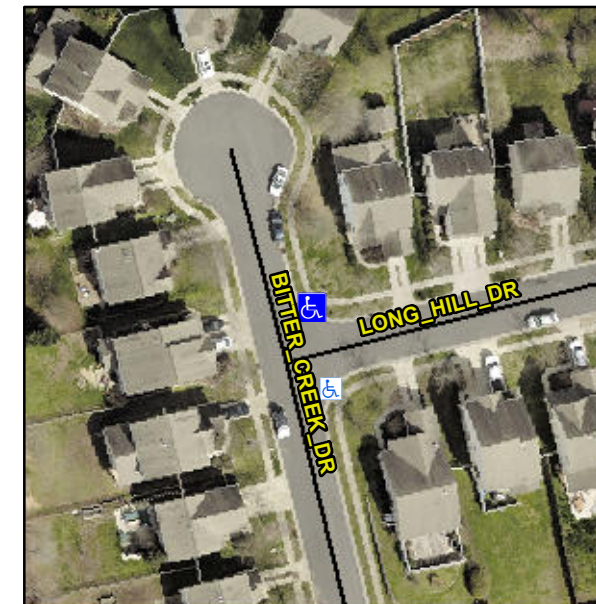
**Not Found, R304.2.2, R304.5.3**

| Compliance | Description | Data | Compliance | Description | Data |
|---|---|---|---|---|---|
| N/A | Ramp Length (in) | 61.0 | No | Ramp Slope (%) | 12.8 |
| Yes | Ramp Width (in) | 48.0 | No | Ramp XSlope (%) | 6.0 |

**Remove & Replace Curb Ramp With Two New Directional Ramps or Equivalent.**
