# Access Compliance Report

## Public Rights-of-Way

### (Curb Ramps)

| Intersection ID: 47611 | Main Street: WYALONG_DR | Cross Street: MINTWORTH_AV | Location: SW |

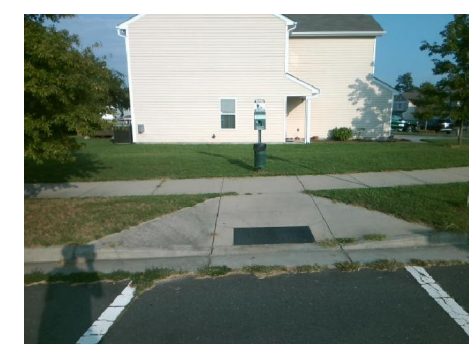
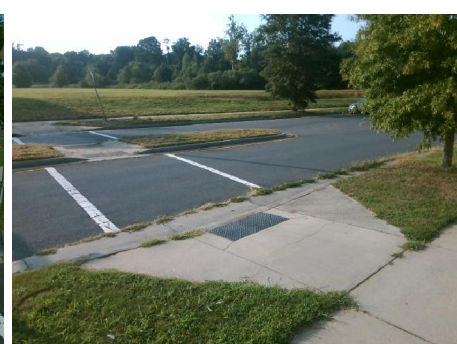
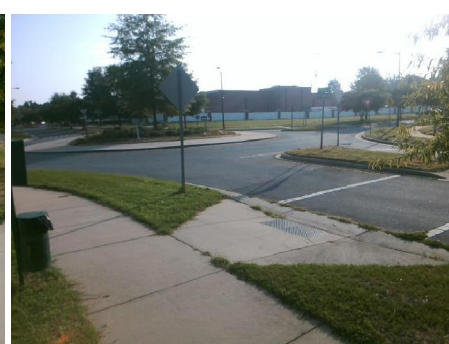
| ADA ID: 2B602171B023 | Ramp Type: Perp | Initial Pass/Fail: Fail | Overall Compliance: No |
| Severity Score: 12.5 | | | |

**Not Found, R304.2.2**

| Compliance | Description | Data | Compliance | Description | Data |
|---|---|---|---|---|---|
| N/A | Ramp Length (in) | 95.0 | No | Ramp Slope (%) | 9.4 |
| Yes | Ramp Width (in) | 72.0 | Yes | Ramp XSlope (%) | 0.8 |

Possible Solutions:

**Remove & Replace Entire Ramp.**

Total Cost: \$ 1850.00
