# Access Compliance Report

## Public Rights-of-Way

### (Curb Ramps)

| Intersection ID: 52457 | Main Street: ORCHARD_LAKE_DR | Cross Street: LUCY_JANE_LN | Location: NW |

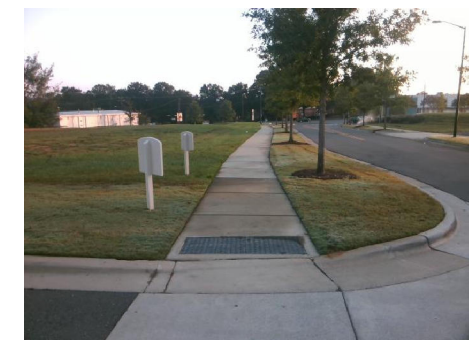
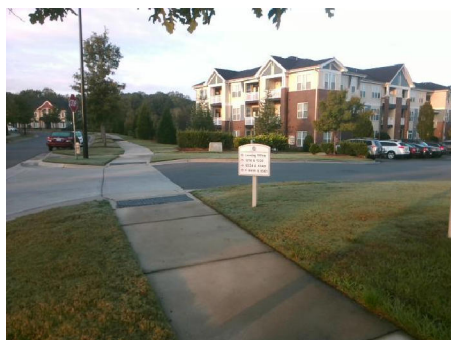
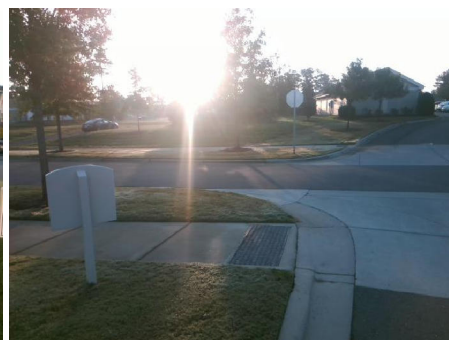
**Not Found, R304.2.2-Perp, R304.3.2-Para, R304.5.3, R304.5.2, R305.1.4, R305.2**

| Compliance | Description | Data | Compliance | Description | Data |
|---|---|---|---|---|---|
| No | Landing Slope (%) | 3.3 | Yes | DWS Length (in) | 24.0 |
| No | Landing X Slope (%) | 2.2 | No | DWS Full Width? | No |

**Remove & Replace Entire Ramp.**
