# Access Compliance Report

## Public Rights-of-Way

### (Curb Ramps)

| Intersection ID: 30179 | Main Street: FAIRSTONE_AV | Cross Street: VECKMAN_CT | Location: NE |

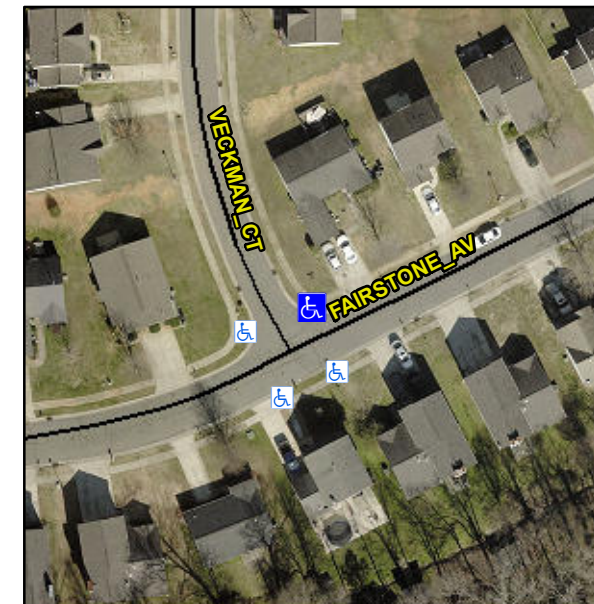
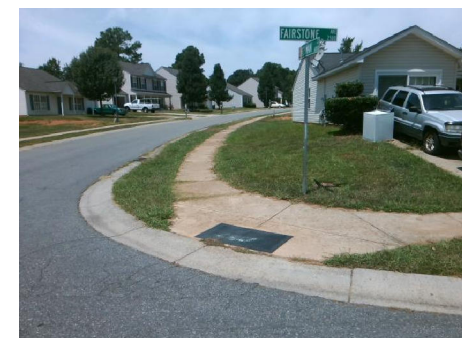
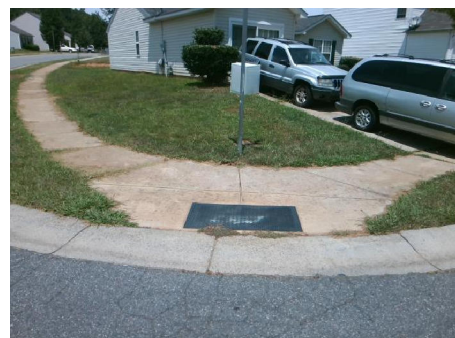
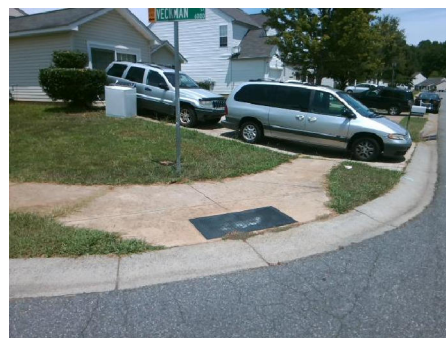
| ADA ID: 2B67B041FEAA | Ramp Type: BlendTrans1 | Initial Pass/Fail: Pass | Overall Compliance: No |
| Severity Score: 7.5 | | | |

**Not Found, R304.2.2-Perp, R304.3.2-Para, R305.1.4, R305.2, R304.5.4**

| Compliance | Description | Data | Compliance | Description | Data |
|---|---|---|---|---|---|
| No | Landing Slope (%) | 3.3 | Yes | DWS Length (in) | 25.5 |
| Yes | Landing X Slope (%) | 1.5 | No | DWS Full Width? | No |
| N/A | Landing Curb? (Y/N) | No | No | DWS Offset (in) | 3.0 |
| Yes | Gutter Ponding? | No | No | Gutter Slope (%) | 6.0 |
| | | | No | Curb Slope (%) | 12.0 |

**Remove & Replace Curb Ramp With Two New Directional Ramps or Equivalent. Remove & Replace Gutter.**

Total Cost: \$ 3950.00
