Intersection ID: 11139		Main Street: EVERETT_PL		Cross Street: PARSON_ST		Location:		SE	
ADA ID: 2B71A717E2C3		Ramp Type: Perp		Initial Pass/Fail: Fail		Overall Compliance: No		Severity Score: 12.5	
Codes/Mitigation Info/Possible Solution				Field Measurements/Component Compliance

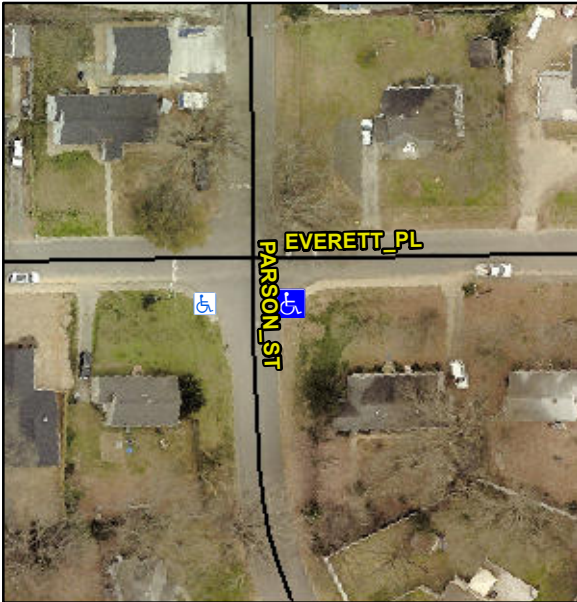
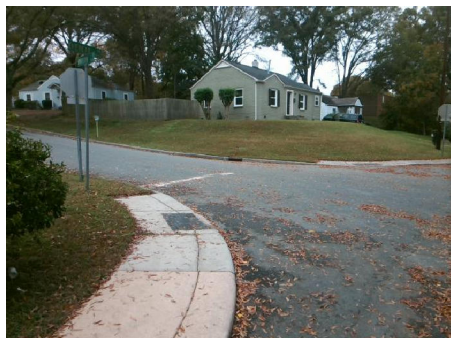
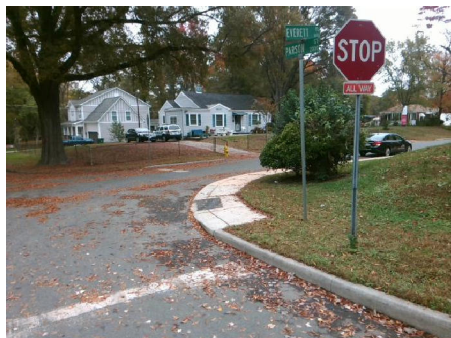
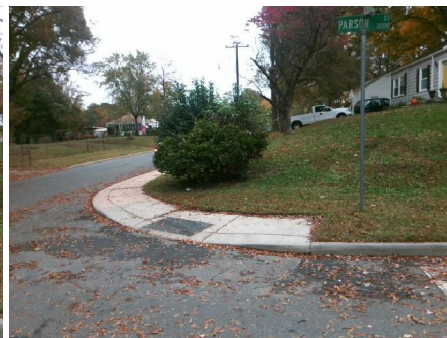
N/A		DWS Offset (in)		N/A	
				N/A					
				N/A		Gutter Ponding?		N/A	
				N/A		Gutter Lip Ht (in)		N/A	
		N/A		Painted X Walk1?		No			
				X Walk 1 Direction		To W			
		N/A		X Walk 1 Width (in)		N/A			
				X Walk 1 Slope (%)		1.8			
				X Walk 1 X Slope (%)		2.1			
		N/A		Ramp inside XWalk1?		N/A			
				Road Slope (%)		N/A			
				Road X Slope (%)		N/A			
		N/A		Any Obstructions?		N/A			
				Obstruction Type					
						N/A			
						Yes			
						Surface Condition? (G/P)			
						Good

Possible Solutions:		Compliance		Description		Data	
		Remove & Replace Entire Ramp.		N/A		Ramp Length (in)		56.0	
				Yes		Ramp Width (in)		48.0	
				N/A		Flare Type LT		N/A	
				N/A		Flare Slope LT (%)		N/A	
				N/A		Flare Traversable LT?		N/A	
				N/A		Landing Length (in)		N/A	
				N/A		Landing Width (in)		N/A	
				N/A		Landing Slope (%)		N/A	
				N/A		Landing X Slope (%)		N/A	
<p>Surveyor Notes:</p> <p>N/A</p> <p>PROW/ADA:</p> <p>Not Found, R304.2.2</p>				N/A		Flare Slope RT (%)		N/A	
				N/A		Flare Traversable RT?		N/A	
				N/A		DWS Provided?		N/A	
				N/A		DWS Contrast?		N/A	
				N/A		DWS Length (in)		N/A	
				N/A		DWS Full Width?		N/A
