# Access Compliance Report

## Public Rights-of-Way

### (Curb Ramps)

Intersection ID: 5946	Main Street: CONIFER_CR	Cross Street: FAIRES_FARM_RD	Location: S
ADA ID: 2B7460C336C0	Ramp Type: Perp	Initial Pass/Fail: Fail	Overall Compliance: No
Severity Score: 21.25			
Codes/Mitigation Info/Possible Solution		Field Measurements/Component Compliance

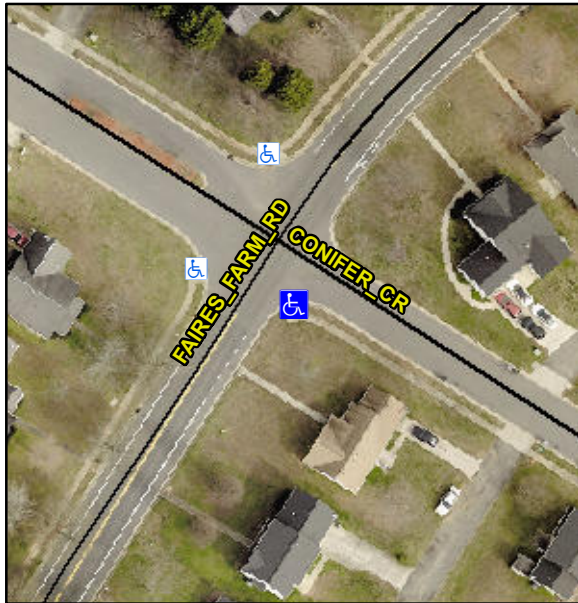
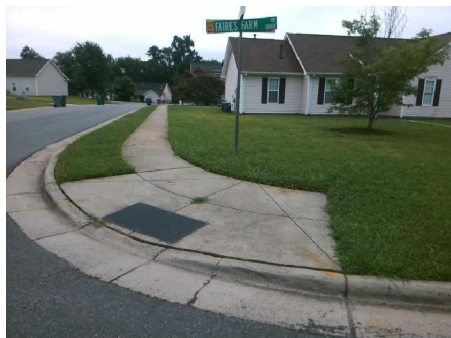
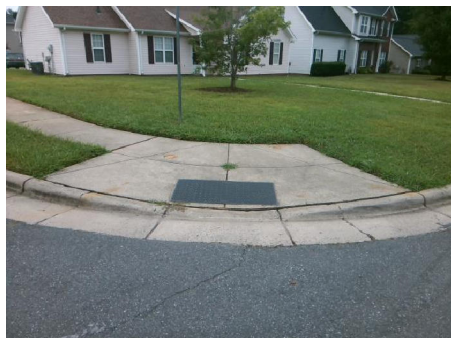
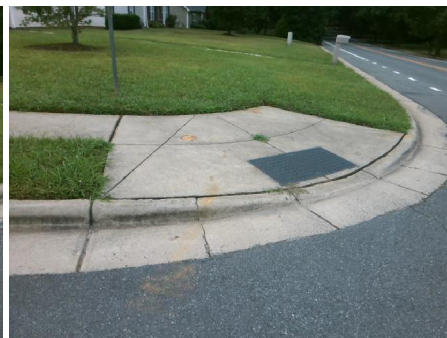
**Not Found, R304.5.1, R304.2.2**

Compliance	Description	Data	Compliance	Description	Data
N/A	Ramp Length (in)	48.5	No	Ramp Slope (%)	9.8
No	Ramp Width (in)	47.5	Yes	Ramp XSlope (%)	2.0
N/A	Flare Type LT	N/A	N/A	Flare Type RT	N/A
N/A	Flare Slope LT (%)	N/A	N/A	Flare Slope RT (%)	N/A
N/A	Flare Traversable LT?	N/A	N/A	Flare Traversable RT?	N/A
N/A	Landing Length (in)	N/A	N/A	DWS Provided?	N/A
N/A	Landing Width (in)	N/A	N/A	DWS Contrast?	N/A
N/A	Landing Slope (%)	N/A	N/A	DWS Length (in)	N/A
N/A	Landing X Slope (%)	N/A	N/A	DWS Full Width?	N/A
N/A	Landing Curb? (Y/N)	N/A	N/A	DWS Offset (in)	N/A
N/A	Shared Landing?	N/A			
N/A	Gutter Ponding?	N/A	N/A	Gutter Slope (%)	N/A
N/A	Gutter Lip Ht (in)	N/A	N/A	Gutter X Slope (%)	N/A
N/A	Painted X Walk1?	No	N/A	Painted X Walk2?	N/A
	X Walk 1 Direction	To W		X Walk 2 Direction	N/A
N/A	X Walk 1 Width (in)	N/A	N/A	X Walk 2 Width (in)	N/A
	X Walk 1 Slope (%)	3.9		X Walk 2 Slope (%)	N/A
	X Walk 1 X Slope (%)	4.1		X Walk 2 X Slope (%)	N/A

N/A	Ramp inside XWalk1?	N/A	N/A	Ramp inside XWalk2?	N/A
	Road Slope (%)	N/A	N/A	Clear Space?	N/A
	Road X Slope (%)	N/A	N/A	Clear Space to XWalk (in)	N/A
N/A	Any Obstructions?	N/A	N/A	Storm Grate/Utility Hazard?	N/A
	Obstruction Type			Storm Grate/Utility Type	
		N/A			N/A
			Yes	Surface Condition? (G/P)	Good

**Remove & Replace Entire Ramp.**

Total Cost: \$ 1850.00
