Access Compliance Report

Public Rights-of-Way

(Curb Ramps)

Intersection ID: 28193	Main Street: MARVIN_RD	Cross Street: JOHNSTON_RD	Location: SE
ADA ID: 2B76EC594AB2	Ramp Type: BlendTrans2	Initial Pass/Fail: Pass	Overall Compliance: No
Severity Score: 0			
Codes/Mitigation Info/Possible Solution		Field Measurements/Component Compliance

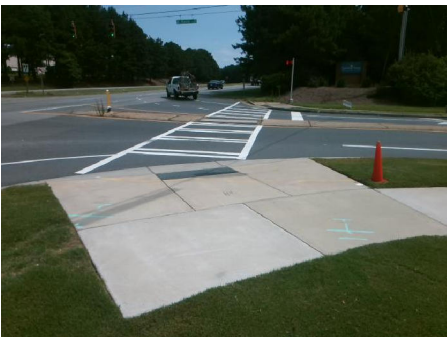
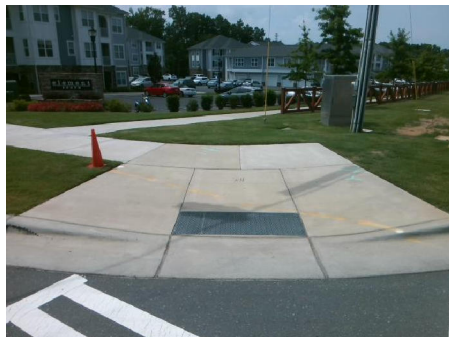
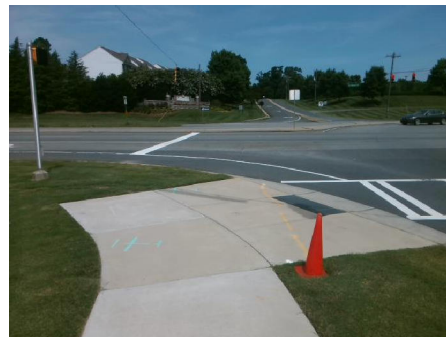
Yes	Ramp inside XWalk1?	Yes	N/A	Ramp inside XWalk2?	N/A
	Road Slope (%)	1.8		Clear Space?	Yes
	Road X Slope (%)	2.5	N/A	Clear Space to XWalk (in)	N/A
Yes	Any Obstructions?	No	Yes	Storm Grate/Utility Hazard?	No
	Obstruction Type			Storm Grate/Utility Type	
		N/A			N/A
			Yes	Surface Condition? (G/P)	Good
			No	Curb Slope (%)	9.5

Remove & Replace Curb Slope and Extend Ramp.
