Access Compliance Report

Public Rights-of-Way

(Curb Ramps)

Intersection ID: N/A	Main Street: E MARTIN LUTHER KING JR BV	Cross Street: S DAVIDSON ST	Location: N
ADA ID: 2B7EE367D481	Ramp Type: PerpDiag	Initial Pass/Fail: Fail	Overall Compliance: No
Codes/Mitigation Info/Possible Solution		Field Measurements/Component Compliance

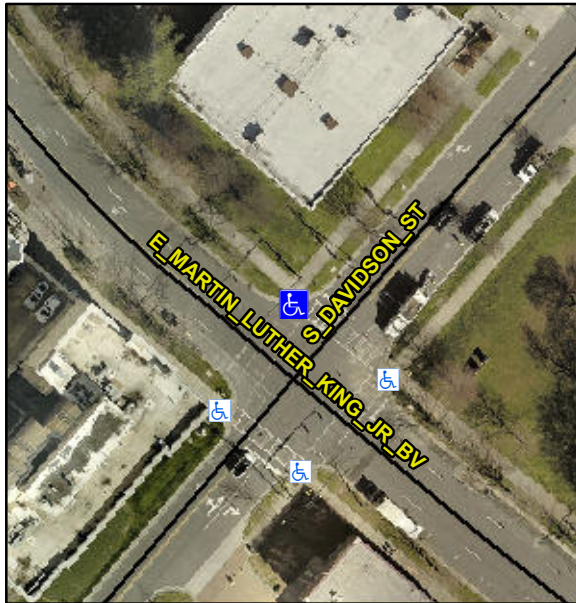
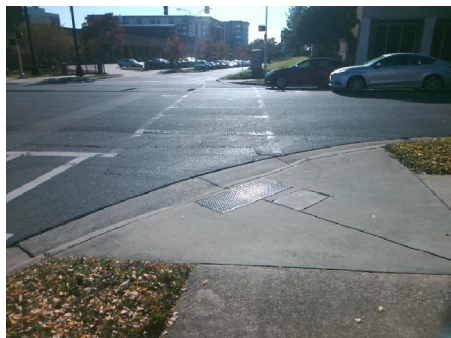
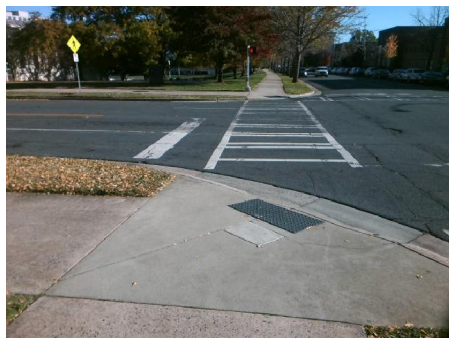
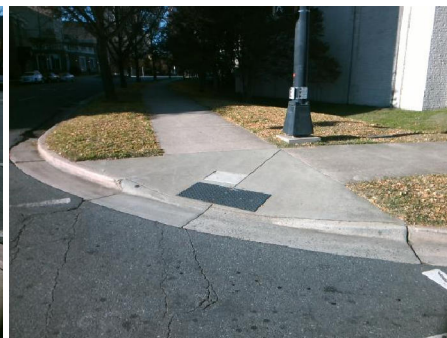
Compliance	Description	Data	Compliance	Description	Data
N/A	Ramp Length (in)	130.0	No	Ramp Slope (%)	8.9
Yes	Ramp Width (in)	60.0	No	Ramp XSlope (%)	3.8
N/A	Flare Type LT	N/A	N/A	Flare Type RT	N/A
N/A	Flare Slope LT (%)	N/A	N/A	Flare Slope RT (%)	N/A
N/A	Flare Traversable LT?	No	N/A	Flare Traversable RT?	No
N/A	Landing Length (in)	N/A	N/A	DWS Provided?	N/A
N/A	Landing Width (in)	N/A	N/A	DWS Contrast?	N/A
N/A	Landing Slope (%)	N/A	N/A	DWS Length (in)	N/A
N/A	Landing X Slope (%)	N/A	N/A	DWS Full Width?	N/A
N/A	Landing Curb? (Y/N)	N/A	N/A	DWS Offset (in)	N/A
N/A	Shared Landing?	N/A			
N/A	Gutter Ponding?	N/A	N/A	Gutter Slope (%)	N/A
N/A	Gutter Lip Ht (in)	N/A	N/A	Gutter X Slope (%)	N/A
N/A	Painted X Walk1?	Yes	N/A	Painted X Walk2?	Yes
	X Walk 1 Direction	To SW		X Walk 2 Direction	To SE
N/A	X Walk 1 Width (in)	110.0	N/A	X Walk 2 Width (in)	110.0
	X Walk 1 Slope (%)	3.3		X Walk 2 Slope (%)	1.5
	X Walk 1 X Slope (%)	3.0		X Walk 2 X Slope (%)	2.6

N/A	Ramp inside XWalk1?	Yes	N/A	Ramp inside XWalk2?	Yes
	Road Slope (%)	3.7	N/A	Clear Space?	N/A
	Road X Slope (%)	0.2	N/A	Clear Space to XWalk (in)	N/A
N/A	Any Obstructions?	N/A	N/A	Storm Grate/Utility Hazard?	N/A
	Obstruction Type			Storm Grate/Utility Type	
		N/A			N/A
			Yes	Surface Condition? (G/P)	Good

Remove & Replace Curb Ramp With Two New Directional Ramps or Equivalent.
