# Access Compliance Report

## Public Rights-of-Way

### (Curb Ramps)

Intersection ID: 13388		Main Street: S_CHURCH_ST		Cross Street: W_SUMMIT_AV		Location: NE			
ADA ID: 2B83505E5FB3		Ramp Type: Perp		Initial Pass/Fail: Fail		Overall Compliance: No		Severity Score: 22.5	
Codes/Mitigation Info/Possible Solution				Field Measurements/Component Compliance

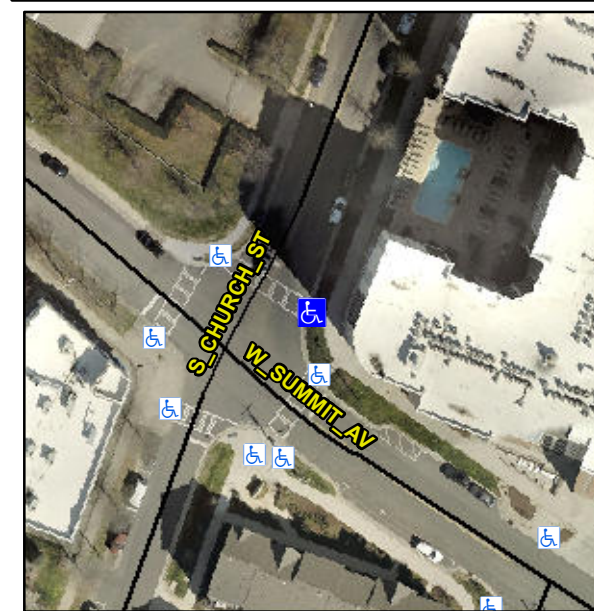
**Not Found, R304.5.1, R304.2.2, R304.5.3**

Compliance	Description	Data	Compliance	Description	Data
N/A	Ramp Length (in)	98.0	No	Ramp Slope (%)	8.9
No	Ramp Width (in)	47.0	No	Ramp XSlope (%)	4.2
N/A	Flare Type LT	N/A	N/A	Flare Type RT	N/A
N/A	Flare Slope LT (%)	N/A	N/A	Flare Slope RT (%)	N/A
N/A	Flare Traversable LT?	N/A	N/A	Flare Traversable RT?	N/A
N/A	Landing Length (in)	N/A	N/A	DWS Provided?	N/A
N/A	Landing Width (in)	N/A	N/A	DWS Contrast?	N/A
N/A	Landing Slope (%)	N/A	N/A	DWS Length (in)	N/A
N/A	Landing X Slope (%)	N/A	N/A	DWS Full Width?	N/A
N/A	Landing Curb? (Y/N)	N/A	N/A	DWS Offset (in)	N/A
N/A	Shared Landing?	N/A			
N/A	Gutter Ponding?	N/A	N/A	Gutter Slope (%)	N/A
N/A	Gutter Lip Ht (in)	N/A	N/A	Gutter X Slope (%)	N/A
N/A	Painted X Walk1?	No	N/A	Painted X Walk2?	N/A
	X Walk 1 Direction	To NW		X Walk 2 Direction	N/A
N/A	X Walk 1 Width (in)	N/A	N/A	X Walk 2 Width (in)	N/A
	X Walk 1 Slope (%)	3.8		X Walk 2 Slope (%)	N/A
	X Walk 1 X Slope (%)	4.2		X Walk 2 X Slope (%)	N/A

N/A	Ramp inside XWalk1?	N/A	N/A	Ramp inside XWalk2?	N/A
	Road Slope (%)	N/A	N/A	Clear Space?	N/A
	Road X Slope (%)	N/A	N/A	Clear Space to XWalk (in)	N/A
N/A	Any Obstructions?	N/A	N/A	Storm Grate/Utility Hazard?	N/A
	Obstruction Type			Storm Grate/Utility Type	
		N/A			N/A
			Yes	Surface Condition? (G/P)	Good

**Remove & Replace Entire Ramp.**
