Access Compliance Report Public Rights-of-Way (Curb Ramps)

Intersection ID: 13301 Main Street: S_TRYON_ST Cross Street: W_CATHERINE_ST Location: SW

ADA ID: 2B871D0808B9 Ramp Type: Perp Initial Pass/Fail: Fail Overall Compliance: No Severity Score: 12.5

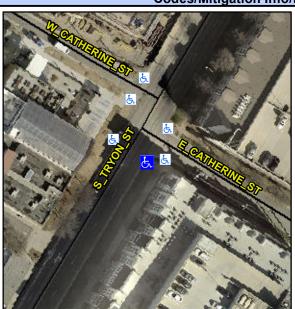
N/A	Ramp Length (in)	50.0	No	Ramp Slope (%)	8.7
Yes	Ramp Width (in)	48.0	Yes	Ramp XSlope (%)	1.1
N/A	Flare Type LT	N/A	N/A	Flare Type RT	N/A
N/A	Flare Slope LT (%)	N/A	N/A	Flare Slope RT (%)	N/A
N/A	Flare Traversable LT?	N/A	N/A	Flare Traversable RT?	N/A
N/A	Landing Length (in)	N/A	N/A	DWS Provided?	N/A
N/A	Landing Width (in)	N/A	N/A	DWS Contrast?	N/A
N/A	Landing Slope (%)	N/A	N/A	DWS Length (in)	N/A
N/A	Landing X Slope (%)	N/A	N/A	DWS Full Width?	N/A
N/A	Landing Curb? (Y/N)	N/A	N/A	DWS Offset (in)	N/A
N/A	Shared Landing?	N/A			
N/A	Gutter Ponding?	N/A	N/A	Gutter Slope (%)	N/A
N/A	Gutter Lip Ht (in)	N/A	N/A	Gutter X Slope (%)	N/A
N/A	Painted X Walk1?	No	N/A	Painted X Walk2?	N/A
	X Walk 1 Direction	To NW		X Walk 2 Direction	N/A
N/A	X Walk 1 Width (in)	N/A	N/A	X Walk 2 Width (in)	N/A
	X Walk 1 Slope (%)	2.2		X Walk 2 Slope (%)	N/A
	X Walk 1 X Slope (%)	2.8		X Walk 2 X Slope (%)	N/A
N/A	Ramp inside XWalk1?	N/A	N/A	Ramp inside XWalk2?	N/A

Road Slope (%)	N/A	N/A	Clear Space?	N/A
	Road X Slope (%)	N/A	N/A	Clear Space to XWalk (in)	N/A
N/A	Any Obstructions?	N/A	N/A	Storm Grate/Utility Hazard?	N/A
	Obstruction Type			Storm Grate/Utility Type	
		N/A			N/A
			Yes	Surface Condition? (G/P)	Good

Possible Solution			Field Me
Possible Solutions:	Compl	iance	Description
Remove & Replace Entire Ramp.	N/A	Ram	p Length (in)
·	Yes	Ram	p Width (in)
	N/A	Flare	Type LT
	N/A	Flare	Slope LT (%)
	N/A	Flare	Traversable LT
	N/A	Land	ing Length (in)
Surveyor Notes:	N/A	Land	ing Width (in)
N/A	N/A	Landing Slope (%)	
	N/A	Land	ing X Slope (%)
	N/A	Land	ing Curb? (Y/N)
	N/A	Shar	ed Landing?
PROW/ADA:	N/A	Gutte	er Ponding?
Not Found, R304.2.2	N/A	Gutte	er Lip Ht (in)
	N/A	Paint	ed X Walk1?
		X Wa	lk 1 Direction
	N/A	X Wa	ılk 1 Width (in)
		X Wa	ılk 1 Slope (%)
		X Wa	ılk 1 X Slone (%

Total Cost:	\$ 1850.00
