Access Compliance Report Public Rights-of-Way (Curb Ramps)

Intersection ID: 5790 Main Street: COULWOOD_DR Cross Street: VALLEYDALE_RD Location: NW

ADA ID: 2B8D872D28D2 Ramp Type: BlendTrans1 Initial Pass/Fail: Fail Overall Compliance: No Severity Score: 8.75

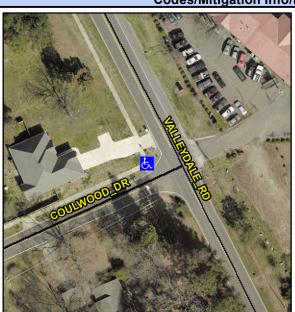
Field Measurements/Component Compliance					
Compliance Description			Compliance Description		Data
N/A	Ramp Length (in)	46.0	Yes	BlendTrans Slope (%)	4.2
No	Ramp Width (in)	44.0	Yes	BlendTrans XSlope (%)	0.2
N/A	Flare Type LT	N/A	N/A	Flare Type RT	N/A
N/A	Flare Slope LT (%)	N/A	N/A	Flare Slope RT (%)	N/A
N/A	Flare Traversable LT?	N/A	N/A	Flare Traversable RT?	N/A
N/A	Landing Length (in)	N/A	N/A	DWS Provided?	N/A
N/A	Landing Width (in)	N/A	N/A	DWS Contrast?	N/A
N/A	Landing Slope (%)	N/A	N/A	DWS Length (in)	N/A
N/A	Landing X Slope (%)	N/A	N/A	DWS Full Width?	N/A
N/A	Landing Curb? (Y/N)	N/A	N/A	DWS Offset (in)	N/A
N/A	Shared Landing?	N/A			
N/A	Gutter Ponding?	N/A	N/A	Gutter Slope (%)	N/A
N/A	Gutter Lip Ht (in)	0.5	N/A	Gutter X Slope (%)	N/A
N/A	Painted X Walk1?	No	N/A	Painted X Walk2?	No
	X Walk 1 Direction	To E		X Walk 2 Direction	N/A
	X Walk 1 Width (in)	N/A		X Walk 2 Width (in)	N/A
	X Walk 1 Slope (%)	1.9		X Walk 2 Slope (%)	N/A

X Walk 1 X Slope (%)	1.7		X Walk 2 X Slope (%)	N/A
N/A	Ramp inside XWalk1?	N/A	N/A	Ramp inside XWalk2?	N/A
	Road Slope (%)	1.7		Clear Space?	N/A
	Road X Slope (%)	1.9	N/A	Clear Space to XWalk (in)	N/A
N/A	Any Obstructions?	N/A	N/A	Storm Grate/Utility Hazard?	N/A
	Obstruction Type		l	Storm Grate/Utility Type	
		N/A	l		N/A
			Yes	Surface Condition? (G/P)	Good
V			N/A	Curb Slope (%)	N/A

Remove & Replace Curb Ramp With Two New Directional Ramps or Equivalent.

PROW/ADA:
R304.5.1
