Access Compliance Report

Public Rights-of-Way

(Curb Ramps)

Intersection ID: 11709	Main Street: W_7TH_ST	Cross Street: N_PINE_ST	Location: E
ADA ID: 2B8E53F75E28	Ramp Type: Perp	Initial Pass/Fail: Fail	Overall Compliance: No
			Severity Score: 26.25

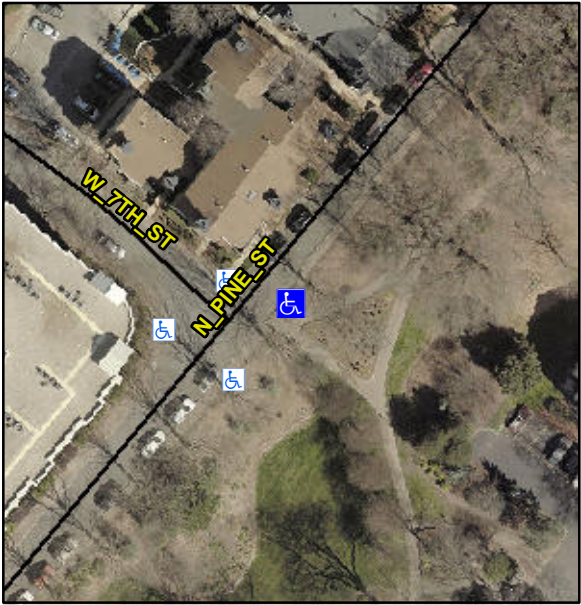
Possible Solutions:		Compliance	Description	Data
	Remove & Replace Entire Ramp.		No	Ramp Length (in)	49.0
			Yes	Ramp Width (in)	68.0
			N/A	Flare Type LT	N/A
			N/A	Flare Slope LT (%)	N/A
			N/A	Flare Traversable LT?	N/A
			N/A	Landing Length (in)	N/A
			N/A	Landing Width (in)	N/A
			N/A	Landing Slope (%)	N/A
			N/A	Landing X Slope (%)	N/A
<p>Surveyor Notes:</p> <p>N/A</p> <p>PROW/ADA:</p> <p>Not Found, R304.2.2, R304.5.3</p>			N/A	Flare Type RT	N/A
			N/A	Flare Slope RT (%)	N/A
			N/A	Flare Traversable RT?	N/A
			N/A	DWS Provided?	N/A
			N/A	DWS Contrast?	N/A
			N/A	DWS Length (in)	N/A
			N/A	DWS Full Width?	N/A
			N/A	DWS Offset (in)	N/A
			N/A	Shared Landing?	N/A
			N/A	Gutter Ponding?	N/A
			N/A	Gutter Lip Ht (in)	N/A
			N/A	Painted X Walk1?	No
				X Walk 1 Direction	To NW
			N/A	X Walk 1 Width (in)	N/A
				X Walk 1 Slope (%)	8.4

X Walk 1 X Slope (%)	1.9
			N/A	Ramp inside XWalk1?	N/A
			N/A	Road Slope (%)	N/A
			N/A	Road X Slope (%)	N/A
			N/A	Any Obstructions?	N/A
				Obstruction Type	
			N/A		
			N/A		
			N/A		
			N/A		
			N/A		
			N/A		
			N/A		
			N/A		
			N/A		
Total Cost:		\$ 1850.00			
			N/A		
			Yes	Surface Condition? (G/P)	Good
