Access Compliance Report

Public Rights-of-Way

(Curb Ramps)

Intersection ID: 10025975	Main Street: ELM_LN	Cross Street: N/A	Location: NW
ADA ID: 2B9B99AEE22C	Ramp Type: Perp	Initial Pass/Fail: Pass	Overall Compliance: No
			Severity Score: 10.25

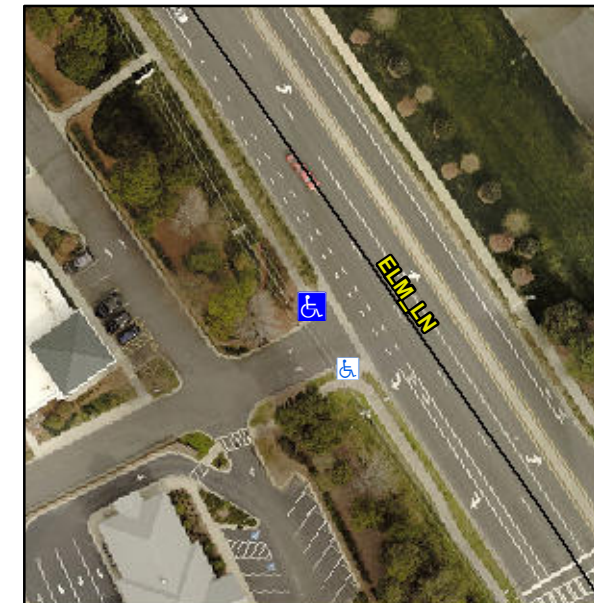
Not Found, R304.5.3, R304.2.1, R304.2.2-Perp, R304.3.2-Para

Compliance	Description	Data	Compliance	Description	Data
N/A	Ramp Length (in)	118.0	Yes	Ramp Slope (%)	5.4
Yes	Ramp Width (in)	48.0	No	Ramp XSlope (%)	2.3
N/A	Flare Type LT	Sloped	N/A	Flare Type RT	N/A
N/A	Flare Slope LT (%)	6.1	Yes	Flare Slope RT (%)	4.3
N/A	Flare Traversable LT?	Yes	N/A	Flare Traversable RT?	Yes
No	Landing Length (in)	N/A	Yes	DWS Provided?	Yes
No	Landing Width (in)	N/A	Yes	DWS Contrast?	Yes
No	Landing Slope (%)	N/A	Yes	DWS Length (in)	24.0
No	Landing X Slope (%)	N/A	Yes	DWS Full Width?	Yes
N/A	Landing Curb? (Y/N)	No	Yes	DWS Offset (in)	1.5
N/A	Shared Landing?	No			
Yes	Gutter Ponding?	No	Yes	Gutter Slope (%)	2.2
Yes	Gutter Lip Ht (in)	0.0	Yes	Gutter X Slope (%)	1.1
N/A	Painted X Walk1?	No	N/A	Painted X Walk2?	N/A
	X Walk 1 Direction	To SE		X Walk 2 Direction	N/A
N/A	X Walk 1 Width (in)	N/A	N/A	X Walk 2 Width (in)	N/A
	X Walk 1 Slope (%)	2.4		X Walk 2 Slope (%)	N/A
	X Walk 1 X Slope (%)	1.4		X Walk 2 X Slope (%)	N/A

N/A	Ramp inside XWalk1?	N/A	N/A	Ramp inside XWalk2?	N/A
	Road Slope (%)	N/A	N/A	Clear Space?	Yes
	Road X Slope (%)	N/A	N/A	Clear Space to XWalk (in)	N/A
Yes	Any Obstructions?	No	Yes	Storm Grate/Utility Hazard?	No
	Obstruction Type			Storm Grate/Utility Type	
			N/A		N/A
			Yes	Surface Condition? (G/P)	Good

Possible Solutions:

Remove & Replace Entire Ramp.
