Access Compliance Report

Public Rights-of-Way

(Curb Ramps)

Intersection ID: 8576	Main Street: BEATTIES_FORD_RD	Cross Street: HILDEBRAND_ST	Location: NW
ADA ID: 2BAB1BE61791	Ramp Type: PerpDiag	Initial Pass/Fail: Fail	Overall Compliance: No
Severity Score: 8.75			
Codes/Mitigation Info/Possible Solution		Field Measurements/Component Compliance

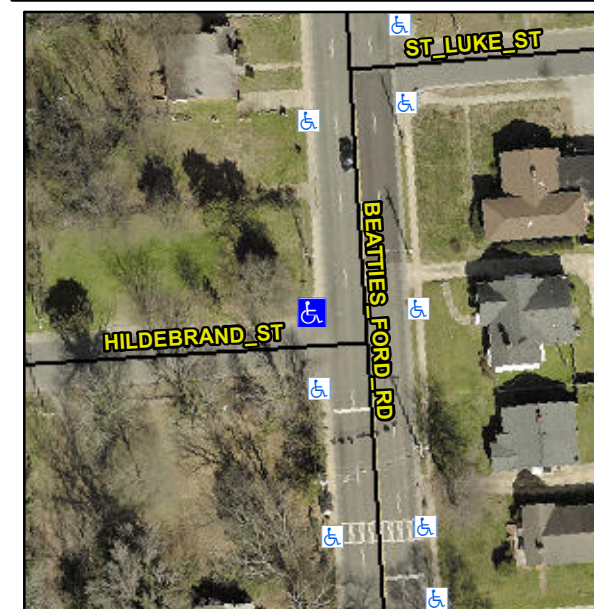
Not Found, R304.5.1

Compliance	Description	Data	Compliance	Description	Data
N/A	Ramp Length (in)	48.5	Yes	Ramp Slope (%)	6.0
No	Ramp Width (in)	47.0	Yes	Ramp XSlope (%)	0.5
N/A	Flare Type LT	N/A	N/A	Flare Type RT	N/A
N/A	Flare Slope LT (%)	N/A	N/A	Flare Slope RT (%)	N/A
N/A	Flare Traversable LT?	N/A	N/A	Flare Traversable RT?	N/A
N/A	Landing Length (in)	N/A	N/A	DWS Provided?	N/A
N/A	Landing Width (in)	N/A	N/A	DWS Contrast?	N/A
N/A	Landing Slope (%)	N/A	N/A	DWS Length (in)	N/A
N/A	Landing X Slope (%)	N/A	N/A	DWS Full Width?	N/A
N/A	Landing Curb? (Y/N)	N/A	N/A	DWS Offset (in)	N/A
N/A	Shared Landing?	N/A			
N/A	Gutter Ponding?	N/A	N/A	Gutter Slope (%)	N/A
N/A	Gutter Lip Ht (in)	N/A	N/A	Gutter X Slope (%)	N/A
N/A	Painted X Walk1?	No	N/A	Painted X Walk2?	No
	X Walk 1 Direction	To S		X Walk 2 Direction	To E
N/A	X Walk 1 Width (in)	N/A	N/A	X Walk 2 Width (in)	N/A
	X Walk 1 Slope (%)	3.1		X Walk 2 Slope (%)	7.3
	X Walk 1 X Slope (%)	1.6		X Walk 2 X Slope (%)	1.3

N/A	Ramp inside XWalk1?	N/A	N/A	Ramp inside XWalk2?	N/A
	Road Slope (%)	0.2	N/A	Clear Space?	N/A
	Road X Slope (%)	4.2	N/A	Clear Space to XWalk (in)	N/A
N/A	Any Obstructions?	N/A	N/A	Storm Grate/Utility Hazard?	N/A
	Obstruction Type			Storm Grate/Utility Type	
		N/A			N/A
		Yes		Surface Condition? (G/P)	Good

Remove & Replace Curb Ramp With Two New Directional Ramps or Equivalent.

Total Cost: \$ 3200.00
