Access Compliance Report

Public Rights-of-Way

(Curb Ramps)

Intersection ID: 7094	Main Street: EQUIPMENT_DR	Cross Street: W_SUGAR_CREEK_RD	Location: E
ADA ID: 2BAD19F0EDAC	Ramp Type: Perp	Initial Pass/Fail: Fail	Overall Compliance: No
Severity Score: 12.5			
Codes/Mitigation Info/Possible Solution		Field Measurements/Component Compliance

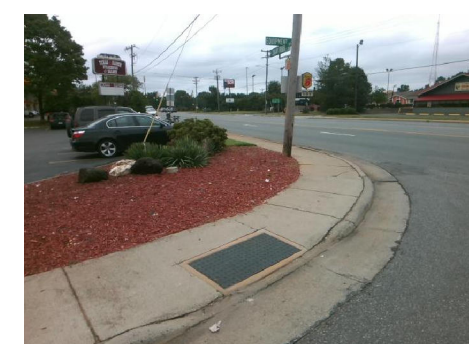
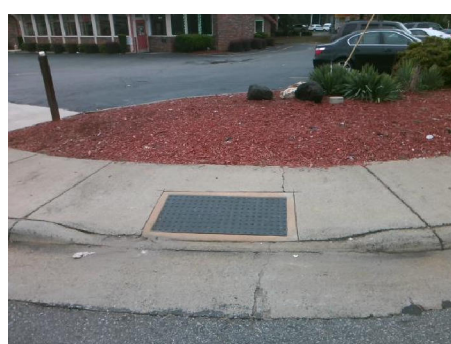
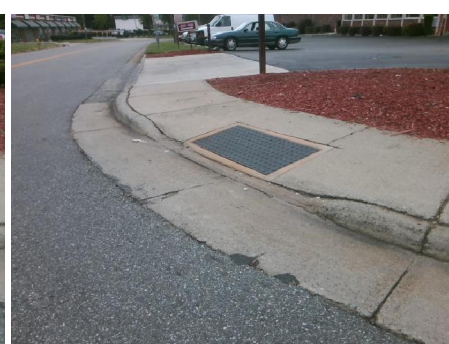
Compliance	Description	Data	Compliance	Description	Data
N/A	Ramp Length (in)	56.5	No	Ramp Slope (%)	11.5
Yes	Ramp Width (in)	54.0	Yes	Ramp XSlope (%)	1.6
N/A	Flare Type LT	N/A	N/A	Flare Type RT	N/A
N/A	Flare Slope LT (%)	N/A	N/A	Flare Slope RT (%)	N/A
N/A	Flare Traversable LT?	N/A	N/A	Flare Traversable RT?	N/A
N/A	Landing Length (in)	N/A	N/A	DWS Provided?	N/A
N/A	Landing Width (in)	N/A	N/A	DWS Contrast?	N/A
N/A	Landing Slope (%)	N/A	N/A	DWS Length (in)	N/A
N/A	Landing X Slope (%)	N/A	N/A	DWS Full Width?	N/A
N/A	Landing Curb? (Y/N)	N/A	N/A	DWS Offset (in)	N/A
N/A	Shared Landing?	N/A			
N/A	Gutter Ponding?	N/A	N/A	Gutter Slope (%)	N/A
N/A	Gutter Lip Ht (in)	N/A	N/A	Gutter X Slope (%)	N/A
N/A	Painted X Walk1?	No	N/A	Painted X Walk2?	N/A
	X Walk 1 Direction	To N		X Walk 2 Direction	N/A
N/A	X Walk 1 Width (in)	N/A	N/A	X Walk 2 Width (in)	N/A
	X Walk 1 Slope (%)	2.7		X Walk 2 Slope (%)	N/A
	X Walk 1 X Slope (%)	1.4		X Walk 2 X Slope (%)	N/A

N/A	Ramp inside XWalk1?	N/A	N/A	Ramp inside XWalk2?	N/A
	Road Slope (%)	1.4	N/A	Clear Space?	N/A
	Road X Slope (%)	2.7	N/A	Clear Space to XWalk (in)	N/A
N/A	Any Obstructions?	N/A	N/A	Storm Grate/Utility Hazard?	N/A
	Obstruction Type			Storm Grate/Utility Type	
		N/A			N/A
			Yes	Surface Condition? (G/P)	Good

Remove & Replace Entire Ramp.
