# Access Compliance Report

## Public Rights-of-Way

### (Curb Ramps)

Intersection ID: 10014519	Main Street: UNIVERSITY_POINTE_BV	Cross Street: N/A	Location: SE
ADA ID: 2BC20EBE68FF	Ramp Type: PerpDiag	Initial Pass/Fail: Fail	Overall Compliance: No
			Severity Score: 33.75

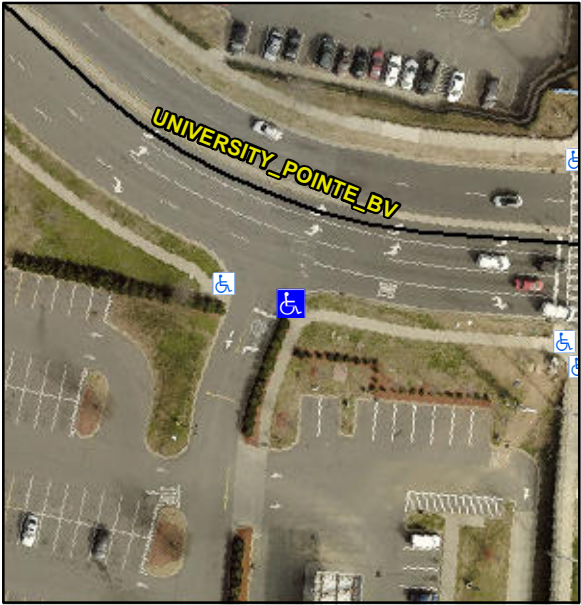
Possible Solutions:		<b>Compliance</b>	<b>Description</b>	<b>Data</b>
	Remove & Replace Curb Ramp With Two New Directional Ramps or Equivalent.		N/A	Ramp Length (in)	88.0
			No	Ramp Width (in)	43.5
			N/A	Flare Type LT	N/A
			N/A	Flare Slope LT (%)	N/A
			N/A	Flare Traversable LT?	N/A
			N/A	Landing Length (in)	N/A
			N/A	Landing Width (in)	N/A
			N/A	Landing Slope (%)	N/A
			N/A	Landing X Slope (%)	N/A
			N/A	Landing Curb? (Y/N)	N/A
			N/A	Shared Landing?	N/A
			N/A	Gutter Ponding?	N/A
			N/A	Gutter Lip Ht (in)	N/A
			N/A	Painted X Walk1?	No
				X Walk 1 Direction	To N
			N/A	X Walk 1 Width (in)	N/A
				X Walk 1 Slope (%)	5.9
				X Walk 1 X Slope (%)	1.5
			N/A	Ramp inside XWalk1?	N/A
<p>Surveyor Notes:</p> <p>N/A</p> <p>PROW/ADA:</p> <p>R304.5.1, R304.5.3</p>			N/A	Flare Type RT	N/A
			N/A	Flare Slope RT (%)	N/A
			N/A	Flare Traversable RT?	N/A

N/A	DWS Provided?	N/A
			N/A	DWS Contrast?	N/A
			N/A	DWS Length (in)	N/A
			N/A	DWS Full Width?	N/A
			N/A	DWS Offset (in)	N/A
			N/A	Gutter Slope (%)	N/A
			N/A	Gutter X Slope (%)	N/A
			N/A	Painted X Walk2?	No
				X Walk 2 Direction	To W
			N/A	X Walk 2 Width (in)	N/A
				X Walk 2 Slope (%)	3.8
				X Walk 2 X Slope (%)	6.0
			N/A	Ramp inside XWalk2?	N/A
			N/A	Clear Space?	N/A
			N/A	Clear Space to XWalk (in)	N/A
			N/A	Storm Grate/Utility Hazard?	N/A
				Storm Grate/Utility Type	
			N/A		N/A
			Yes	Surface Condition? (G/P)	Good
Total Cost:		\$ 3200.00
