# Access Compliance Report

## Public Rights-of-Way

### (Curb Ramps)

| Intersection ID: 26417 | Main Street: BONNIE BUTLER_WY | Cross Street: RHETT BUTLER_PL | Location: NE |

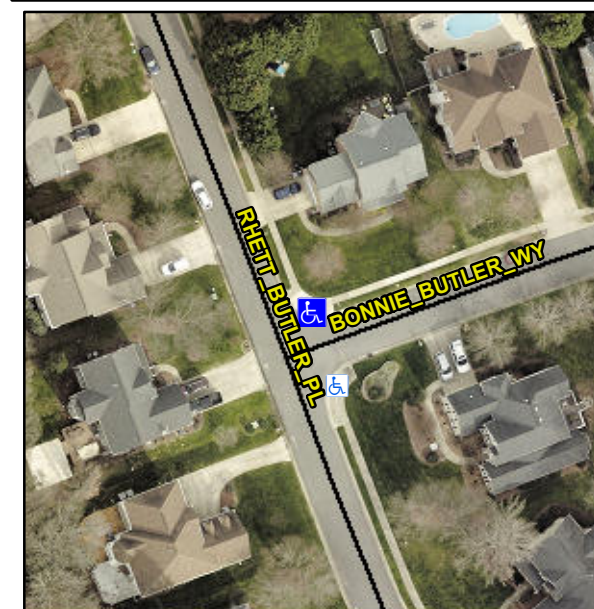
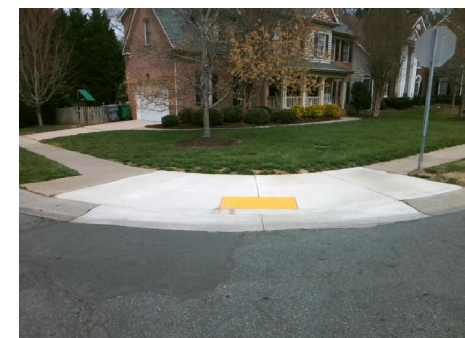
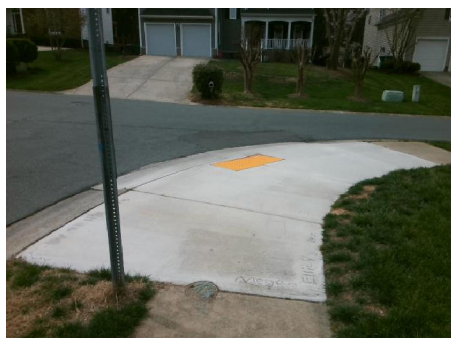
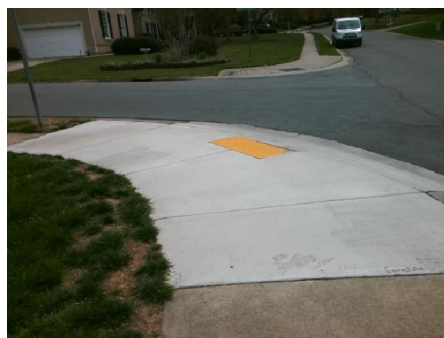
| ADA ID: 2BC364BE8DAD | Ramp Type: BlendTrans1 | Initial Pass/Fail: Pass | Overall Compliance: No |
| Severity Score: 5 | | | |

| Compliance | Description | Data | Compliance | Description | Data |
|---|---|---|---|---|---|
| N/A | Landing Curb? (Y/N) | No | No | DWS Offset (in) | 8.0 |
| Yes | Gutter Ponding? | No | No | Gutter Slope (%) | 8.3 |
| Yes | Gutter Lip Ht (in) | 0.0 | No | Gutter X Slope (%) | 2.3 |

Possible Solutions:

**Remove & Replace Detectable Warning System. Remove & Replace Gutter.**

**R305.2, R304.5.4, R304.5.3**

Total Cost: \$ 1550.00
