Access Compliance Report

Public Rights-of-Way

(Curb Ramps)

Intersection ID: 46758	Main Street: CUMBERLAND_COVE_DR	Cross Street: SUPERIOR_ST	Location: SE
ADA ID: 2BC4062F2EA1	Ramp Type: PerpDiag	Initial Pass/Fail: Fail	Overall Compliance: No
Severity Score: 22.5			
Codes/Mitigation Info/Possible Solution		Field Measurements/Component Compliance

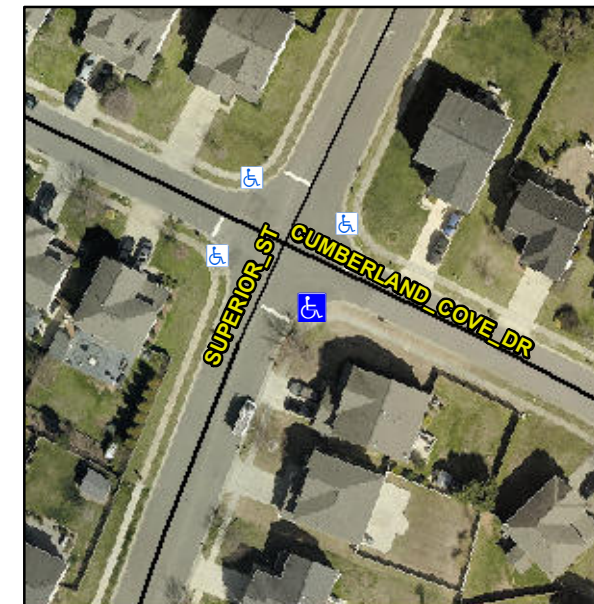
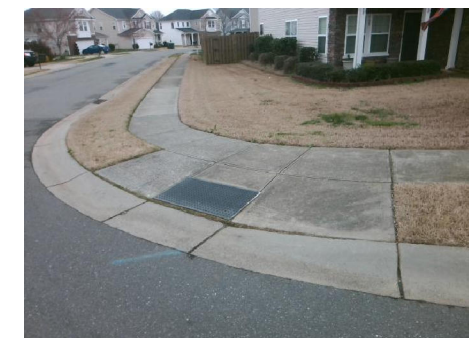
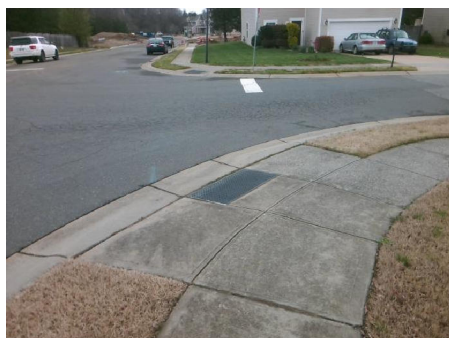
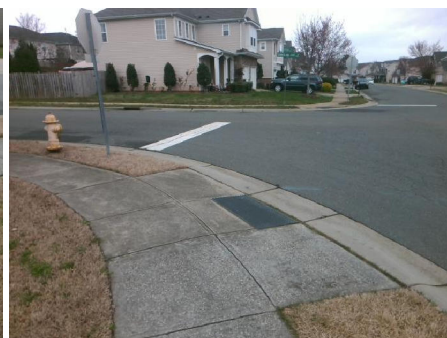
Compliance	Description	Data	Compliance	Description	Data
N/A	Ramp Length (in)	48.0	No	Ramp Slope (%)	11.8
No	Ramp Width (in)	43.0	No	Ramp XSlope (%)	3.1
N/A	Flare Type LT	N/A	N/A	Flare Type RT	N/A
N/A	Flare Slope LT (%)	N/A	N/A	Flare Slope RT (%)	N/A
N/A	Flare Traversable LT?	N/A	N/A	Flare Traversable RT?	N/A
N/A	Landing Length (in)	N/A	N/A	DWS Provided?	N/A
N/A	Landing Width (in)	N/A	N/A	DWS Contrast?	N/A
N/A	Landing Slope (%)	N/A	N/A	DWS Length (in)	N/A
N/A	Landing X Slope (%)	N/A	N/A	DWS Full Width?	N/A
N/A	Landing Curb? (Y/N)	N/A	N/A	DWS Offset (in)	N/A
N/A	Shared Landing?	N/A			
N/A	Gutter Ponding?	N/A	N/A	Gutter Slope (%)	N/A
N/A	Gutter Lip Ht (in)	N/A	N/A	Gutter X Slope (%)	N/A
N/A	Painted X Walk1?	No	N/A	Painted X Walk2?	No
	X Walk 1 Direction	To NE		X Walk 2 Direction	To NW
N/A	X Walk 1 Width (in)	N/A	N/A	X Walk 2 Width (in)	N/A
	X Walk 1 Slope (%)	4.3		X Walk 2 Slope (%)	2.1
	X Walk 1 X Slope (%)	2.2		X Walk 2 X Slope (%)	4.4

N/A	Ramp inside XWalk1?	N/A	N/A	Ramp inside XWalk2?	N/A
	Road Slope (%)	3.9	N/A	Clear Space?	N/A
	Road X Slope (%)	1.9	N/A	Clear Space to XWalk (in)	N/A
N/A	Any Obstructions?	N/A	N/A	Storm Grate/Utility Hazard?	N/A
	Obstruction Type			Storm Grate/Utility Type	
		N/A			N/A
			Yes	Surface Condition? (G/P)	Good

Possible Solutions:

Remove & Replace Curb Ramp With Two New Directional Ramps or Equivalent.

R304.5.1, R304.2.2, R304.5.3
