Access Compliance Report

Public Rights-of-Way

(Curb Ramps)

Intersection ID: 10017965	Main Street: ROCKWELL_CHURCH_RD	Cross Street: N/A	Location:	N
ADA ID: 2BCABDC618D2	Ramp Type: Perp	Initial Pass/Fail: Fail	Overall Compliance: No	Severity Score: 22.5

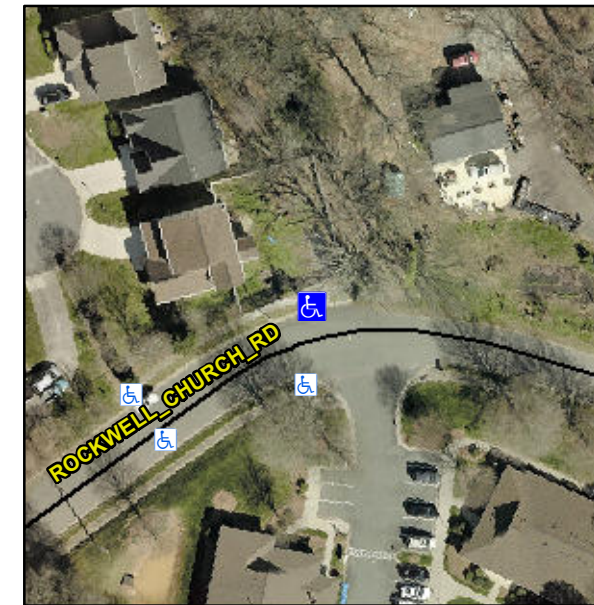
Not Found, R304.5.1, R304.2.2, R304.5.3

Compliance	Description	Data	Compliance	Description	Data
N/A	Ramp Length (in)	48.0	No	Ramp Slope (%)	9.6
No	Ramp Width (in)	47.0	No	Ramp XSlope (%)	3.0
N/A	Flare Type LT	N/A	N/A	Flare Type RT	N/A
N/A	Flare Slope LT (%)	N/A	N/A	Flare Slope RT (%)	N/A
N/A	Flare Traversable LT?	N/A	N/A	Flare Traversable RT?	N/A
N/A	Landing Length (in)	N/A	N/A	DWS Provided?	N/A
N/A	Landing Width (in)	N/A	N/A	DWS Contrast?	N/A
N/A	Landing Slope (%)	N/A	N/A	DWS Length (in)	N/A
N/A	Landing X Slope (%)	N/A	N/A	DWS Full Width?	N/A
N/A	Landing Curb? (Y/N)	N/A	N/A	DWS Offset (in)	N/A
N/A	Shared Landing?	N/A			
N/A	Gutter Ponding?	N/A	N/A	Gutter Slope (%)	N/A
N/A	Gutter Lip Ht (in)	N/A	N/A	Gutter X Slope (%)	N/A
N/A	Painted X Walk1?	No	N/A	Painted X Walk2?	N/A
	X Walk 1 Direction	To S		X Walk 2 Direction	N/A
N/A	X Walk 1 Width (in)	N/A	N/A	X Walk 2 Width (in)	N/A
	X Walk 1 Slope (%)	10.1		X Walk 2 Slope (%)	N/A
	X Walk 1 X Slope (%)	1.5		X Walk 2 X Slope (%)	N/A

N/A	Ramp inside XWalk1?	N/A	N/A	Ramp inside XWalk2?	N/A
	Road Slope (%)	N/A	N/A	Clear Space?	N/A
	Road X Slope (%)	N/A	N/A	Clear Space to XWalk (in)	N/A
N/A	Any Obstructions?	N/A	N/A	Storm Grate/Utility Hazard?	N/A
	Obstruction Type			Storm Grate/Utility Type	
		N/A			N/A
			Yes	Surface Condition? (G/P)	Good

Remove & Replace Entire Ramp.

Total Cost: \$ 1850.00
