Access Compliance Report

Public Rights-of-Way

(Curb Ramps)

Intersection ID: 21819	Main Street: AUTUMN_BLAZE_DR	Cross Street: POPLAR_FOREST_DR	Location: W
ADA ID: 2BD6C8CEEA16	Ramp Type: BlendTrans2	Initial Pass/Fail: Fail	Overall Compliance: No
		Severity Score: 8.75

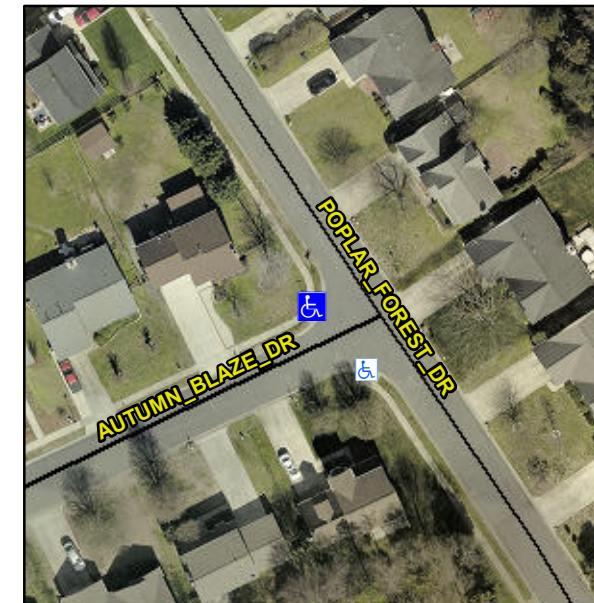
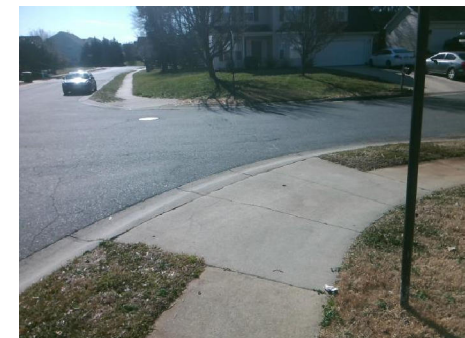
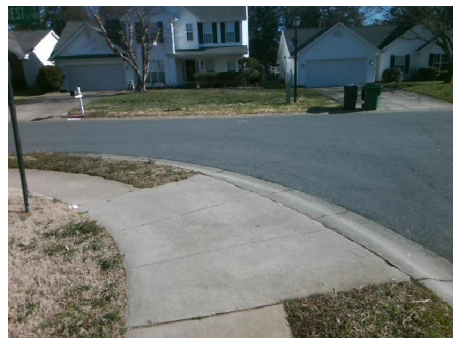
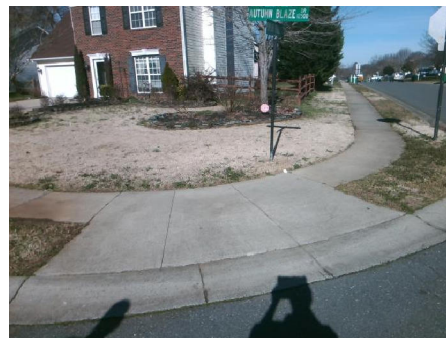
Compliance	Description	Data	Compliance	Description	Data
N/A	Ramp Length (in)	92.0	Yes	BlendTrans Slope (%)	3.8
No	Ramp Width (in)	36.5	Yes	BlendTrans XSlope (%)	0.1
N/A	Flare Type LT	N/A	N/A	Flare Type RT	N/A
N/A	Flare Slope LT (%)	N/A	N/A	Flare Slope RT (%)	N/A
N/A	Flare Traversable LT?	N/A	N/A	Flare Traversable RT?	N/A
N/A	Landing Length (in)	N/A	N/A	DWS Provided?	N/A
N/A	Landing Width (in)	N/A	N/A	DWS Contrast?	N/A
N/A	Landing Slope (%)	N/A	N/A	DWS Length (in)	N/A
N/A	Landing X Slope (%)	N/A	N/A	DWS Full Width?	N/A
N/A	Landing Curb? (Y/N)	N/A	N/A	DWS Offset (in)	N/A
N/A	Shared Landing?	N/A			
N/A	Gutter Ponding?	N/A	N/A	Gutter Slope (%)	N/A
N/A	Gutter Lip Ht (in)	N/A	N/A	Gutter X Slope (%)	N/A
N/A	Painted X Walk1?	No	N/A	Painted X Walk2?	No
	X Walk 1 Direction	To SE		X Walk 2 Direction	To NE
	X Walk 1 Width (in)	N/A		X Walk 2 Width (in)	N/A
	X Walk 1 Slope (%)	3.7		X Walk 2 Slope (%)	1.5
	X Walk 1 X Slope (%)	1.6		X Walk 2 X Slope (%)	0.3

N/A	Ramp inside XWalk1?	N/A	N/A	Ramp inside XWalk2?	N/A
	Road Slope (%)	0.7		Clear Space?	N/A
	Road X Slope (%)	2.8	N/A	Clear Space to XWalk (in)	N/A
N/A	Any Obstructions?	N/A	N/A	Storm Grate/Utility Hazard?	N/A
	Obstruction Type			Storm Grate/Utility Type	
		N/A			N/A
			Yes	Surface Condition? (G/P)	Good
			N/A	Curb Slope (%)	1.9

Remove & Replace Curb Ramp With Two New Directional Ramps or Equivalent.
