Access Compliance Report

Public Rights-of-Way

(Curb Ramps)

Intersection ID: 47910	Main Street: ROOK_RD	Cross Street: MOUNTAIN_QUAIL_DR	Location:	N
ADA ID: 2BDB6B6D1652	Ramp Type: PerpDiag	Initial Pass/Fail: Fail	Overall Compliance: No	Severity Score: 22.5
Codes/Mitigation Info/Possible Solution		Field Measurements/Component Compliance

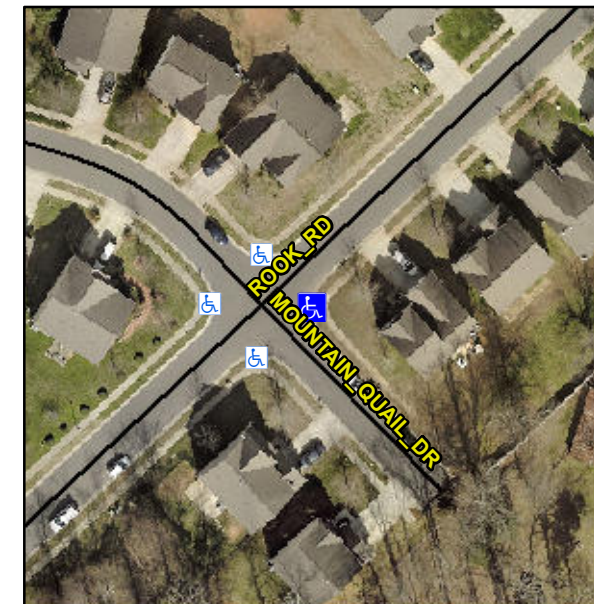
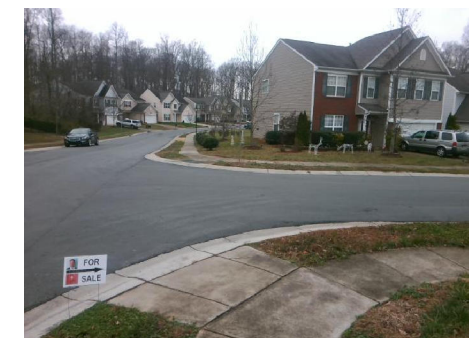
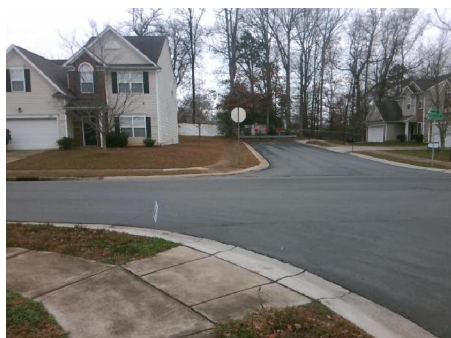
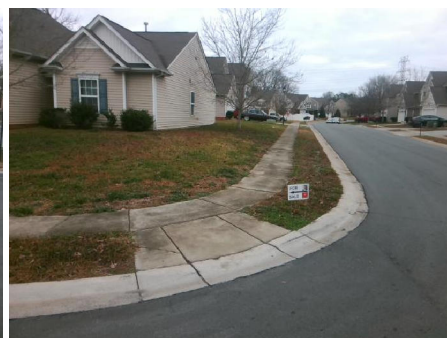
Not Found, R304.5.1, R304.2.2, R304.5.3

Compliance	Description	Data	Compliance	Description	Data
N/A	Ramp Length (in)	52.0	No	Ramp Slope (%)	8.5
No	Ramp Width (in)	40.0	No	Ramp XSlope (%)	3.5
N/A	Flare Type LT	N/A	N/A	Flare Type RT	N/A
N/A	Flare Slope LT (%)	N/A	N/A	Flare Slope RT (%)	N/A
N/A	Flare Traversable LT?	N/A	N/A	Flare Traversable RT?	N/A
N/A	Landing Length (in)	N/A	N/A	DWS Provided?	N/A
N/A	Landing Width (in)	N/A	N/A	DWS Contrast?	N/A
N/A	Landing Slope (%)	N/A	N/A	DWS Length (in)	N/A
N/A	Landing X Slope (%)	N/A	N/A	DWS Full Width?	N/A
N/A	Landing Curb? (Y/N)	N/A	N/A	DWS Offset (in)	N/A
N/A	Shared Landing?	N/A			
N/A	Gutter Ponding?	N/A	N/A	Gutter Slope (%)	N/A
N/A	Gutter Lip Ht (in)	N/A	N/A	Gutter X Slope (%)	N/A
N/A	Painted X Walk1?	No	N/A	Painted X Walk2?	No
	X Walk 1 Direction	To SW		X Walk 2 Direction	To SE
N/A	X Walk 1 Width (in)	N/A	N/A	X Walk 2 Width (in)	N/A
	X Walk 1 Slope (%)	0.3		X Walk 2 Slope (%)	3.7
	X Walk 1 X Slope (%)	3.3		X Walk 2 X Slope (%)	0.6

N/A	Ramp inside XWalk1?	N/A	N/A	Ramp inside XWalk2?	N/A
	Road Slope (%)	1.4	N/A	Clear Space?	N/A
	Road X Slope (%)	2.1	N/A	Clear Space to XWalk (in)	N/A
N/A	Any Obstructions?	N/A	N/A	Storm Grate/Utility Hazard?	N/A
	Obstruction Type			Storm Grate/Utility Type	
		N/A			N/A
			Yes	Surface Condition? (G/P)	Good

Remove & Replace Curb Ramp With Two New Directional Ramps or Equivalent.
