Access Compliance Report

Public Rights-of-Way

(Curb Ramps)

Intersection ID: N/A	Main Street: LAKESIDE_DR	Cross Street: KRISTEN_LAKE_CT	Location: NW
ADA ID: 2BE1C8E5F677	Ramp Type: PerpDiag	Initial Pass/Fail: Fail	Overall Compliance: No
		Severity Score: 50

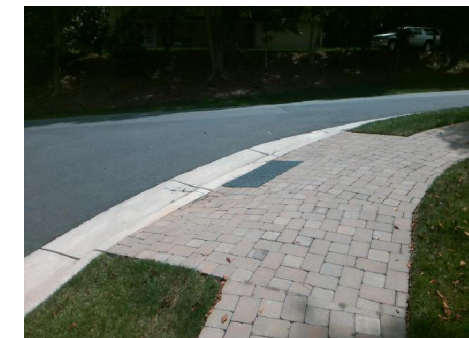
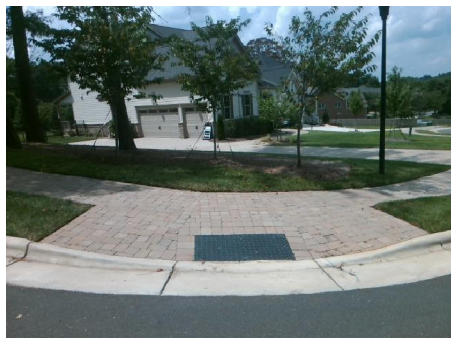
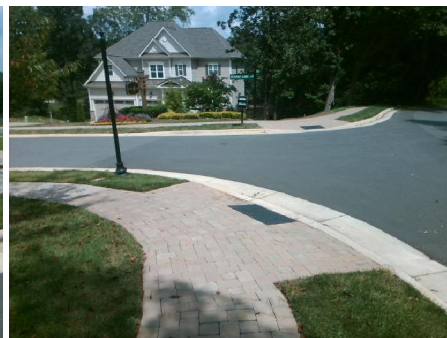
Not Found, R304.2.2, R304.5.3

Compliance	Description	Data	Compliance	Description	Data
N/A	Ramp Length (in)	49.0	No	Ramp Slope (%)	16.0
Yes	Ramp Width (in)	48.0	No	Ramp XSlope (%)	8.9
N/A	Flare Type LT	N/A	N/A	Flare Type RT	N/A
N/A	Flare Slope LT (%)	N/A	N/A	Flare Slope RT (%)	N/A
N/A	Flare Traversable LT?	N/A	N/A	Flare Traversable RT?	N/A
N/A	Landing Length (in)	N/A	N/A	DWS Provided?	N/A
N/A	Landing Width (in)	N/A	N/A	DWS Contrast?	N/A
N/A	Landing Slope (%)	N/A	N/A	DWS Length (in)	N/A
N/A	Landing X Slope (%)	N/A	N/A	DWS Full Width?	N/A
N/A	Landing Curb? (Y/N)	N/A	N/A	DWS Offset (in)	N/A
N/A	Shared Landing?	N/A			
N/A	Gutter Ponding?	N/A	N/A	Gutter Slope (%)	N/A
N/A	Gutter Lip Ht (in)	N/A	N/A	Gutter X Slope (%)	N/A
N/A	Painted X Walk1?	No	N/A	Painted X Walk2?	No
	X Walk 1 Direction	To S		X Walk 2 Direction	To E
N/A	X Walk 1 Width (in)	N/A	N/A	X Walk 2 Width (in)	N/A
	X Walk 1 Slope (%)	6.8		X Walk 2 Slope (%)	3.5
	X Walk 1 X Slope (%)	3.6		X Walk 2 X Slope (%)	6.0

N/A	Ramp inside XWalk1?	N/A	N/A	Ramp inside XWalk2?	N/A
	Road Slope (%)	8.8	N/A	Clear Space?	N/A
	Road X Slope (%)	2.0	N/A	Clear Space to XWalk (in)	N/A
N/A	Any Obstructions?	N/A	N/A	Storm Grate/Utility Hazard?	N/A
	Obstruction Type			Storm Grate/Utility Type	
		N/A			N/A
		Yes		Surface Condition? (G/P)	Good

Remove & Replace Curb Ramp With Two New Directional Ramps or Equivalent.
