# Access Compliance Report

## Public Rights-of-Way

### (Curb Ramps)

Intersection ID: 45137	Main Street: LITTLE_WHITEOAK_RD	Cross Street: CATTAIL_CT	Location: NW
ADA ID: 2BEF43925599	Ramp Type: PerpDiag	Initial Pass/Fail: Fail	Overall Compliance: No
Severity Score: 21.25			
Codes/Mitigation Info/Possible Solution		Field Measurements/Component Compliance

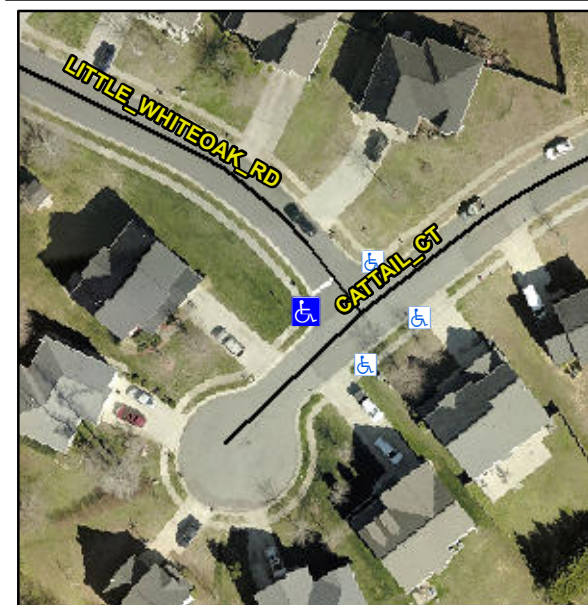
**Not Found, R304.5.1, R304.5.3**

Compliance	Description	Data	Compliance	Description	Data
N/A	Ramp Length (in)	47.0	Yes	Ramp Slope (%)	6.7
No	Ramp Width (in)	39.0	No	Ramp XSlope (%)	6.6
N/A	Flare Type LT	N/A	N/A	Flare Type RT	N/A
N/A	Flare Slope LT (%)	N/A	N/A	Flare Slope RT (%)	N/A
N/A	Flare Traversable LT?	N/A	N/A	Flare Traversable RT?	N/A
N/A	Landing Length (in)	N/A	N/A	DWS Provided?	N/A
N/A	Landing Width (in)	N/A	N/A	DWS Contrast?	N/A
N/A	Landing Slope (%)	N/A	N/A	DWS Length (in)	N/A
N/A	Landing X Slope (%)	N/A	N/A	DWS Full Width?	N/A
N/A	Landing Curb? (Y/N)	N/A	N/A	DWS Offset (in)	N/A
N/A	Shared Landing?	N/A			
N/A	Gutter Ponding?	N/A	N/A	Gutter Slope (%)	N/A
N/A	Gutter Lip Ht (in)	N/A	N/A	Gutter X Slope (%)	N/A
N/A	Painted X Walk1?	No	N/A	Painted X Walk2?	No
	X Walk 1 Direction	To SE		X Walk 2 Direction	To NE
N/A	X Walk 1 Width (in)	N/A	N/A	X Walk 2 Width (in)	N/A
	X Walk 1 Slope (%)	3.6		X Walk 2 Slope (%)	5.0
	X Walk 1 X Slope (%)	4.5		X Walk 2 X Slope (%)	1.5

N/A	Ramp inside XWalk1?	N/A	N/A	Ramp inside XWalk2?	N/A
	Road Slope (%)	5.8	N/A	Clear Space?	N/A
	Road X Slope (%)	2.6	N/A	Clear Space to XWalk (in)	N/A
N/A	Any Obstructions?	N/A	N/A	Storm Grate/Utility Hazard?	N/A
	Obstruction Type			Storm Grate/Utility Type	
		N/A			N/A
			Yes	Surface Condition? (G/P)	Good

**Remove & Replace Curb Ramp With Two New Directional Ramps or Equivalent.**
