# Access Compliance Report

## Public Rights-of-Way

### (Curb Ramps)

Intersection ID: 7771	Main Street: SENIOR_DR	Cross Street: TWINFIELD_DR	Location: SW
ADA ID: 2BF349B82347	Ramp Type: Perp	Initial Pass/Fail: Fail	Overall Compliance: No
		Severity Score: 17.5

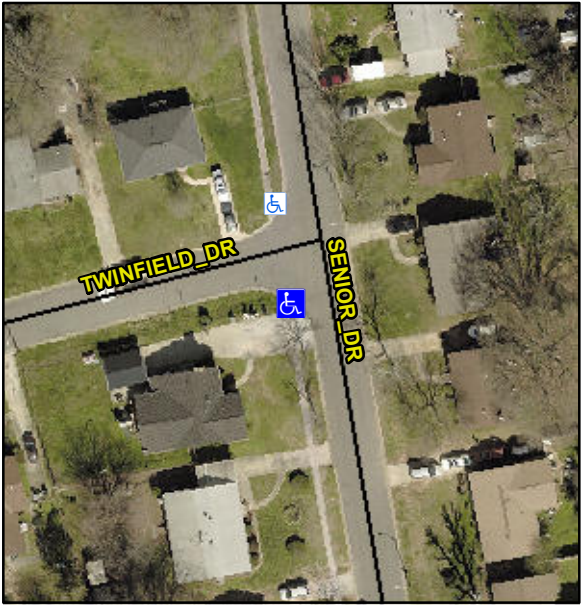
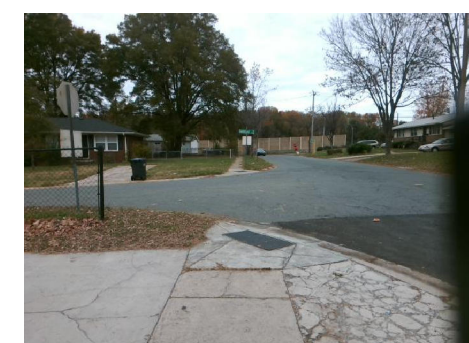
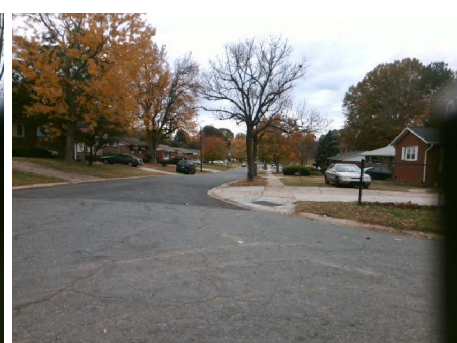
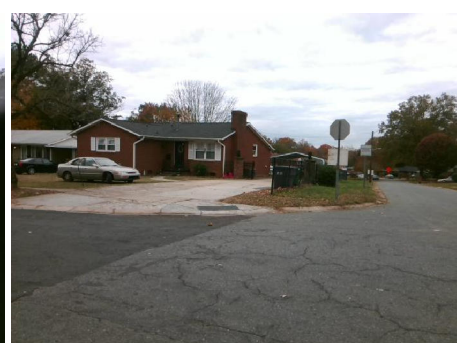
Possible Solutions:		<b>Compliance</b>	<b>Description</b>	<b>Data</b>
	Remove & Replace Entire Ramp.		N/A	Ramp Length (in)	55.5
			No	Ramp Width (in)	35.5
			N/A	Flare Type LT	N/A
			N/A	Flare Slope LT (%)	N/A
			N/A	Flare Traversable LT?	N/A
			N/A	Landing Length (in)	N/A
			N/A	Landing Width (in)	N/A
			N/A	Landing Slope (%)	N/A
			N/A	Landing X Slope (%)	N/A
<p>Surveyor Notes:</p> <p>N/A</p> <p>PROW/ADA:</p> <p>R304.5.1</p>			N/A	Flare Type RT	N/A
			N/A	Flare Slope RT (%)	N/A
			N/A	Flare Traversable RT?	N/A
			N/A	DWS Provided?	N/A
			N/A	DWS Contrast?	N/A
			N/A	DWS Length (in)	N/A
			N/A	DWS Full Width?	N/A
			N/A	DWS Offset (in)	N/A
			N/A	Gutter Ponding?	N/A
			N/A	Gutter Lip Ht (in)	N/A
			N/A	Painted X Walk1?	No
				X Walk 1 Direction	To N
			N/A	X Walk 1 Width (in)	N/A
				X Walk 1 Slope (%)	0.8
				X Walk 1 X Slope (%)	1.8

N/A	Ramp inside XWalk1?	N/A
				Road Slope (%)	N/A
				Road X Slope (%)	N/A
			N/A	Any Obstructions?	N/A
				Obstruction Type	
Total Cost:			\$	1850.00	
					N/A
				Yes	Surface Condition? (G/P)
					Good
