Access Compliance Report

Public Rights-of-Way

(Curb Ramps)

Intersection ID: 2596	Main Street: FAIRVISTA_DR	Cross Street: KNIGHTSGATE_CT	Location: SE
ADA ID: 2BF4CFE46B1D	Ramp Type: PerpDiag	Initial Pass/Fail: Fail	Overall Compliance: No
Severity Score: 8.75			
Codes/Mitigation Info/Possible Solution		Field Measurements/Component Compliance

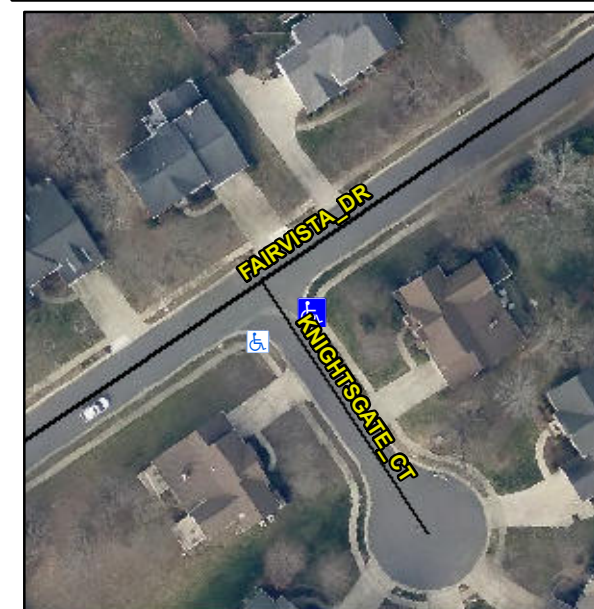
Not Found, R304.5.1

Compliance	Description	Data	Compliance	Description	Data
N/A	Ramp Length (in)	45.5	Yes	Ramp Slope (%)	7.3
No	Ramp Width (in)	41.0	Yes	Ramp XSlope (%)	0.3
N/A	Flare Type LT	N/A	N/A	Flare Type RT	N/A
N/A	Flare Slope LT (%)	N/A	N/A	Flare Slope RT (%)	N/A
N/A	Flare Traversable LT?	N/A	N/A	Flare Traversable RT?	N/A
N/A	Landing Length (in)	N/A	N/A	DWS Provided?	N/A
N/A	Landing Width (in)	N/A	N/A	DWS Contrast?	N/A
N/A	Landing Slope (%)	N/A	N/A	DWS Length (in)	N/A
N/A	Landing X Slope (%)	N/A	N/A	DWS Full Width?	N/A
N/A	Landing Curb? (Y/N)	N/A	N/A	DWS Offset (in)	N/A
N/A	Shared Landing?	N/A			
N/A	Gutter Ponding?	N/A	N/A	Gutter Slope (%)	N/A
N/A	Gutter Lip Ht (in)	N/A	N/A	Gutter X Slope (%)	N/A
N/A	Painted X Walk1?	No	N/A	Painted X Walk2?	No
	X Walk 1 Direction	To N		X Walk 2 Direction	To W
N/A	X Walk 1 Width (in)	N/A	N/A	X Walk 2 Width (in)	N/A
	X Walk 1 Slope (%)	3.9		X Walk 2 Slope (%)	0.6
	X Walk 1 X Slope (%)	3.9		X Walk 2 X Slope (%)	0.7

N/A	Ramp inside XWalk1?	N/A	N/A	Ramp inside XWalk2?	N/A
	Road Slope (%)	0.9	N/A	Clear Space?	N/A
	Road X Slope (%)	0.3	N/A	Clear Space to XWalk (in)	N/A
N/A	Any Obstructions?	N/A	N/A	Storm Grate/Utility Hazard?	N/A
	Obstruction Type			Storm Grate/Utility Type	
		N/A			N/A
			Yes	Surface Condition? (G/P)	Good

Remove & Replace Curb Ramp With Two New Directional Ramps or Equivalent.

Total Cost: \$ 3200.00
