# Access Compliance Report

## Public Rights-of-Way

| Intersection ID: 21123 | Main Street: RUTHERFORD_DR | Cross Street: SHARON_RD | Location: SW |
| ADA ID: 2BF663C8F1A3 | Ramp Type: PerpDiag | Initial Pass/Fail: Pass | Overall Compliance: No |

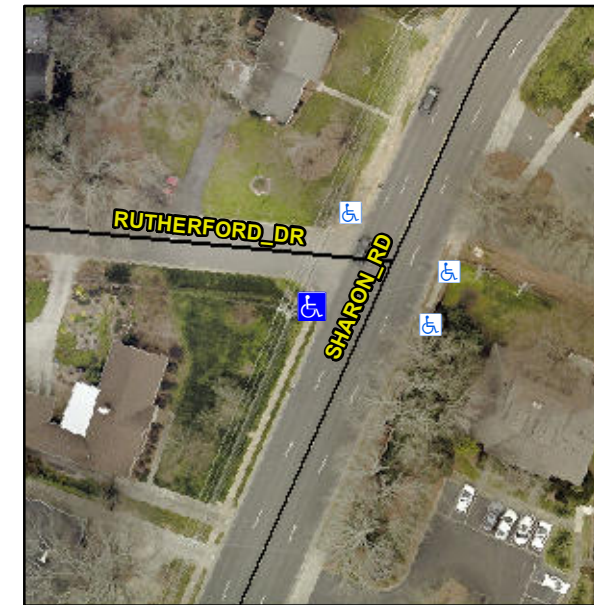
**R304.2.1, R304.2.2-Perp, R304.3.2-Para, R304.5.3, R305**

| Compliance | Description | Data | Compliance | Description | Data |
|---|---|---|---|---|---|
| No | Landing Length (in) | N/A | No | DWS Provided? | No |
| No | Landing Width (in) | N/A | N/A | DWS Contrast? | No |
| No | Landing Slope (%) | N/A | N/A | DWS Length (in) | N/A |
| No | Landing X Slope (%) | N/A | N/A | DWS Full Width? | No |
| Yes | Gutter Lip Ht (in) | 0.0 | No | Gutter X Slope (%) | 2.2 |

**Remove & Replace Curb Ramp With Two New Directional Ramps or Equivalent. Remove & Replace Gutter.**
