Access Compliance Report

Public Rights-of-Way

(Curb Ramps)

Intersection ID: 42683	Main Street: RUNNYMEDE_LN	Cross Street: SHARON_RD	Location: SW
ADA ID: 2BF705DB03A0	Ramp Type: Perp	Initial Pass/Fail: Fail	Overall Compliance: No
Severity Score: 22.5			
Codes/Mitigation Info/Possible Solution		Field Measurements/Component Compliance

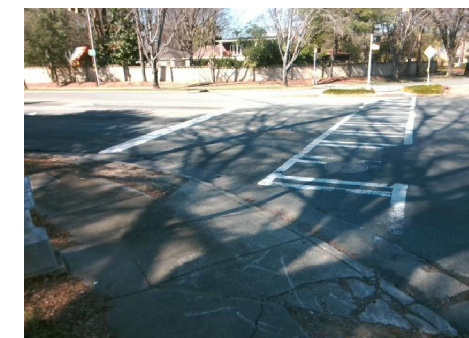
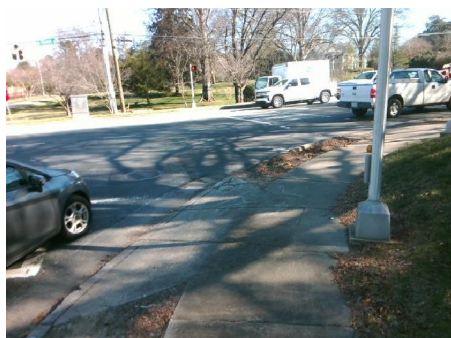
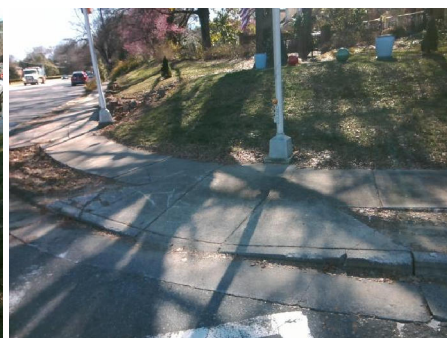
Not Found, R304.5.1, R304.2.2, R304.5.3

Compliance	Description	Data	Compliance	Description	Data
N/A	Ramp Length (in)	74.0	No	Ramp Slope (%)	11.6
No	Ramp Width (in)	41.0	No	Ramp XSlope (%)	2.6
N/A	Flare Type LT	N/A	N/A	Flare Type RT	N/A
N/A	Flare Slope LT (%)	N/A	N/A	Flare Slope RT (%)	N/A
N/A	Flare Traversable LT?	N/A	N/A	Flare Traversable RT?	N/A
N/A	Landing Length (in)	N/A	N/A	DWS Provided?	N/A
N/A	Landing Width (in)	N/A	N/A	DWS Contrast?	N/A
N/A	Landing Slope (%)	N/A	N/A	DWS Length (in)	N/A
N/A	Landing X Slope (%)	N/A	N/A	DWS Full Width?	N/A
N/A	Landing Curb? (Y/N)	N/A	N/A	DWS Offset (in)	N/A
N/A	Shared Landing?	N/A			
N/A	Gutter Ponding?	N/A	N/A	Gutter Slope (%)	N/A
N/A	Gutter Lip Ht (in)	N/A	N/A	Gutter X Slope (%)	N/A
N/A	Painted X Walk1?	Yes	N/A	Painted X Walk2?	N/A
	X Walk 1 Direction	To NW		X Walk 2 Direction	N/A
N/A	X Walk 1 Width (in)	80.0	N/A	X Walk 2 Width (in)	N/A
	X Walk 1 Slope (%)	0.5		X Walk 2 Slope (%)	N/A
	X Walk 1 X Slope (%)	2.2		X Walk 2 X Slope (%)	N/A

N/A	Ramp inside XWalk1?	Yes	N/A	Ramp inside XWalk2?	N/A
	Road Slope (%)	N/A	N/A	Clear Space?	N/A
	Road X Slope (%)	N/A	N/A	Clear Space to XWalk (in)	N/A
N/A	Any Obstructions?	N/A	N/A	Storm Grate/Utility Hazard?	N/A
	Obstruction Type			Storm Grate/Utility Type	
		N/A			N/A
			Yes	Surface Condition? (G/P)	Good

Remove & Replace Entire Ramp.
