Access Compliance Report

Public Rights-of-Way

(Curb Ramps)

Intersection ID: 43935	Main Street: TRELLIS_POINTE_BV	Cross Street: CIRCUMFERENTIAL_RD	Location: S
ADA ID: 2C00E67E030B	Ramp Type: PerpDiag	Initial Pass/Fail: Fail	Overall Compliance: No
Severity Score: 8.75			
Codes/Mitigation Info/Possible Solution		Field Measurements/Component Compliance

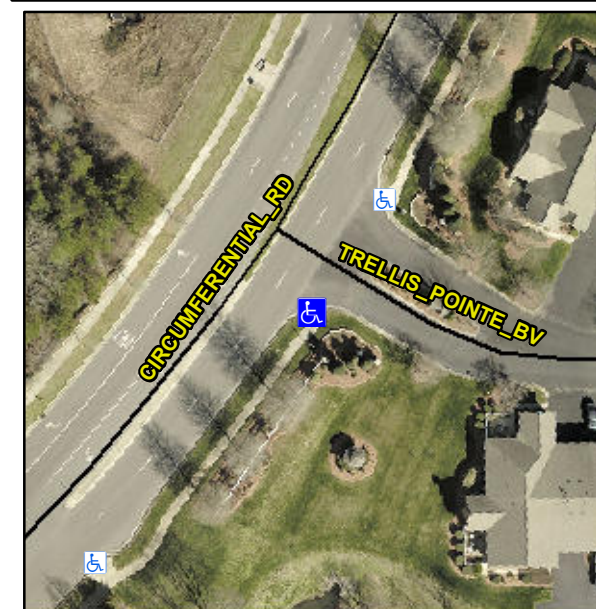
Compliance	Description	Data	Compliance	Description	Data
N/A	Ramp Length (in)	90.0	Yes	Ramp Slope (%)	7.2
No	Ramp Width (in)	46.0	Yes	Ramp XSlope (%)	2.0
N/A	Flare Type LT	N/A	N/A	Flare Type RT	N/A
N/A	Flare Slope LT (%)	N/A	N/A	Flare Slope RT (%)	N/A
N/A	Flare Traversable LT?	N/A	N/A	Flare Traversable RT?	N/A
N/A	Landing Length (in)	N/A	N/A	DWS Provided?	N/A
N/A	Landing Width (in)	N/A	N/A	DWS Contrast?	N/A
N/A	Landing Slope (%)	N/A	N/A	DWS Length (in)	N/A
N/A	Landing X Slope (%)	N/A	N/A	DWS Full Width?	N/A
N/A	Landing Curb? (Y/N)	N/A	N/A	DWS Offset (in)	N/A
N/A	Shared Landing?	N/A			
N/A	Gutter Ponding?	N/A	N/A	Gutter Slope (%)	N/A
N/A	Gutter Lip Ht (in)	N/A	N/A	Gutter X Slope (%)	N/A
N/A	Painted X Walk1?	No	N/A	Painted X Walk2?	No
	X Walk 1 Direction	To NE		X Walk 2 Direction	To NW
N/A	X Walk 1 Width (in)	N/A	N/A	X Walk 2 Width (in)	N/A
	X Walk 1 Slope (%)	4.0		X Walk 2 Slope (%)	0.4
	X Walk 1 X Slope (%)	0.1		X Walk 2 X Slope (%)	1.9

N/A	Ramp inside XWalk1?	N/A	N/A	Ramp inside XWalk2?	N/A
	Road Slope (%)	1.7	N/A	Clear Space?	N/A
	Road X Slope (%)	2.8	N/A	Clear Space to XWalk (in)	N/A
N/A	Any Obstructions?	N/A	N/A	Storm Grate/Utility Hazard?	N/A
	Obstruction Type			Storm Grate/Utility Type	
		N/A			N/A
			Yes	Surface Condition? (G/P)	Good

Remove & Replace Curb Ramp With Two New Directional Ramps or Equivalent.

R304.5.1

\$ 3200.00
