Access Compliance Report

Public Rights-of-Way

(Curb Ramps)

Intersection ID: 13450	Main Street: S_MCDOWELL_ST	Cross Street: E_MARTIN_LUTHER_KING_JR_BV	Location: S
ADA ID: 2C07905F0FF1	Ramp Type: PerpDiag	Initial Pass/Fail: Fail	Overall Compliance: No
Severity Score: 10			
Codes/Mitigation Info/Possible Solution		Field Measurements/Component Compliance

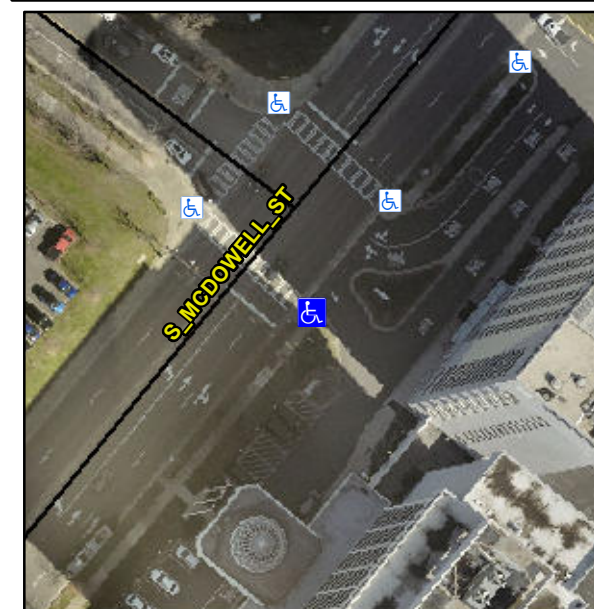
Compliance	Description	Data	Compliance	Description	Data
N/A	Ramp Length (in)	60.0	Yes	Ramp Slope (%)	6.3
No	Ramp Width (in)	42.0	Yes	Ramp XSlope (%)	3.2
N/A	Flare Type LT	N/A	N/A	Flare Type RT	N/A
N/A	Flare Slope LT (%)	N/A	N/A	Flare Slope RT (%)	N/A
N/A	Flare Traversable LT?	N/A	N/A	Flare Traversable RT?	N/A
N/A	Landing Length (in)	N/A	N/A	DWS Provided?	N/A
N/A	Landing Width (in)	N/A	N/A	DWS Contrast?	N/A
N/A	Landing Slope (%)	N/A	N/A	DWS Length (in)	N/A
N/A	Landing X Slope (%)	N/A	N/A	DWS Full Width?	N/A
N/A	Landing Curb? (Y/N)	N/A	N/A	DWS Offset (in)	N/A
N/A	Shared Landing?	N/A			
N/A	Gutter Ponding?	N/A	N/A	Gutter Slope (%)	N/A
N/A	Gutter Lip Ht (in)	N/A	N/A	Gutter X Slope (%)	N/A
N/A	Painted X Walk1?	No	N/A	Painted X Walk2?	Yes
	X Walk 1 Direction	To NE		X Walk 2 Direction	To NW
N/A	X Walk 1 Width (in)	N/A	N/A	X Walk 2 Width (in)	110.0
	X Walk 1 Slope (%)	1.0		X Walk 2 Slope (%)	2.7
	X Walk 1 X Slope (%)	4.6		X Walk 2 X Slope (%)	2.0

N/A	Ramp inside XWalk1?	N/A	N/A	Ramp inside XWalk2?	Yes
	Road Slope (%)	5.1	N/A	Clear Space?	N/A
	Road X Slope (%)	3.3	N/A	Clear Space to XWalk (in)	N/A
N/A	Any Obstructions?	N/A	N/A	Storm Grate/Utility Hazard?	N/A
	Obstruction Type			Storm Grate/Utility Type	
		N/A			N/A
			Yes	Surface Condition? (G/P)	Good

Remove & Replace Curb Ramp With Two New Directional Ramps or Equivalent.

R304.5.1
