Access Compliance Report

Public Rights-of-Way

(Curb Ramps)

Intersection ID: 10031127	Main Street: MARGARET_WALLACE_RD	Cross Street: N/A	Location: NE
ADA ID: 2C14940C3484	Ramp Type: PerpDiag	Initial Pass/Fail: Fail	Overall Compliance: No
Severity Score: 35			
Codes/Mitigation Info/Possible Solution		Field Measurements/Component Compliance

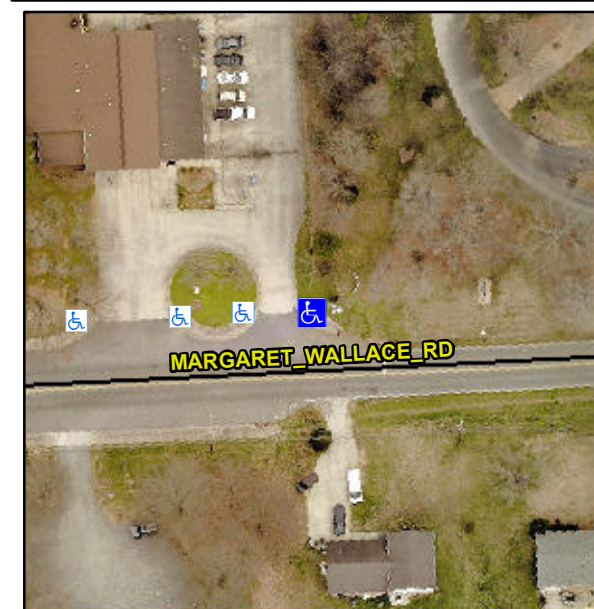
Not Found, R304.5.1

Compliance	Description	Data	Compliance	Description	Data
N/A	Ramp Length (in)	60.5	Yes	Ramp Slope (%)	5.3
No	Ramp Width (in)	24.0	Yes	Ramp XSlope (%)	0.9
N/A	Flare Type LT	N/A	N/A	Flare Type RT	N/A
N/A	Flare Slope LT (%)	N/A	N/A	Flare Slope RT (%)	N/A
N/A	Flare Traversable LT?	N/A	N/A	Flare Traversable RT?	N/A
N/A	Landing Length (in)	N/A	N/A	DWS Provided?	N/A
N/A	Landing Width (in)	N/A	N/A	DWS Contrast?	N/A
N/A	Landing Slope (%)	N/A	N/A	DWS Length (in)	N/A
N/A	Landing X Slope (%)	N/A	N/A	DWS Full Width?	N/A
N/A	Landing Curb? (Y/N)	N/A	N/A	DWS Offset (in)	N/A
N/A	Shared Landing?	N/A			
N/A	Gutter Ponding?	N/A	N/A	Gutter Slope (%)	N/A
N/A	Gutter Lip Ht (in)	N/A	N/A	Gutter X Slope (%)	N/A
N/A	Painted X Walk1?	No	N/A	Painted X Walk2?	No
	X Walk 1 Direction	To W		X Walk 2 Direction	To S
N/A	X Walk 1 Width (in)	N/A	N/A	X Walk 2 Width (in)	N/A
	X Walk 1 Slope (%)	0.9		X Walk 2 Slope (%)	2.0
	X Walk 1 X Slope (%)	2.3		X Walk 2 X Slope (%)	0.3

N/A	Ramp inside XWalk1?	N/A	N/A	Ramp inside XWalk2?	N/A
	Road Slope (%)	0.5	N/A	Clear Space?	N/A
	Road X Slope (%)	1.6	N/A	Clear Space to XWalk (in)	N/A
N/A	Any Obstructions?	N/A	N/A	Storm Grate/Utility Hazard?	N/A
	Obstruction Type			Storm Grate/Utility Type	
		N/A			N/A
			Yes	Surface Condition? (G/P)	Good

Possible Solutions:

Remove & Replace Curb Ramp With Two New Directional Ramps or Equivalent.
