Access Compliance Report

Public Rights-of-Way

(Curb Ramps)

Intersection ID: 13743	Main Street: DR_CARVER_RD	Cross Street: WEST_BV	Location: NW
ADA ID: 2C1C764F5AA4	Ramp Type: PerpDiag	Initial Pass/Fail: Fail	Overall Compliance: No
		Severity Score: 30

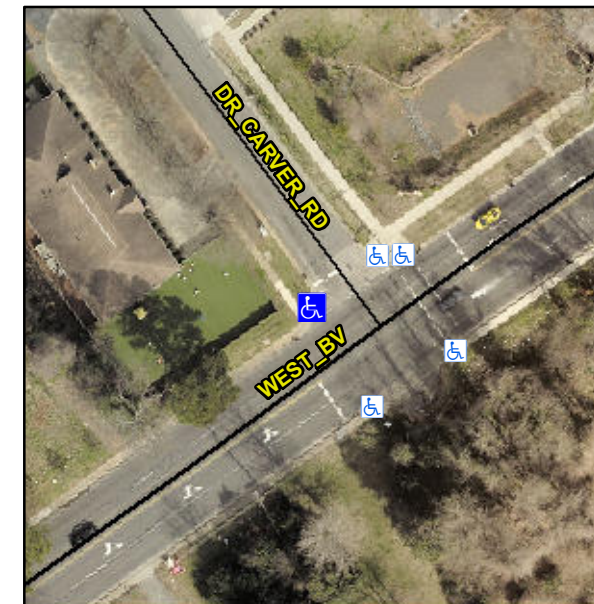
Not Found, R304.5.1, R304.2.2

Compliance	Description	Data	Compliance	Description	Data
N/A	Ramp Length (in)	47.0	No	Ramp Slope (%)	9.3
No	Ramp Width (in)	32.0	Yes	Ramp XSlope (%)	1.5
N/A	Flare Type LT	N/A	N/A	Flare Type RT	N/A
N/A	Flare Slope LT (%)	N/A	N/A	Flare Slope RT (%)	N/A
N/A	Flare Traversable LT?	N/A	N/A	Flare Traversable RT?	N/A
N/A	Landing Length (in)	N/A	N/A	DWS Provided?	N/A
N/A	Landing Width (in)	N/A	N/A	DWS Contrast?	N/A
N/A	Landing Slope (%)	N/A	N/A	DWS Length (in)	N/A
N/A	Landing X Slope (%)	N/A	N/A	DWS Full Width?	N/A
N/A	Landing Curb? (Y/N)	N/A	N/A	DWS Offset (in)	N/A
N/A	Shared Landing?	N/A			
N/A	Gutter Ponding?	N/A	N/A	Gutter Slope (%)	N/A
N/A	Gutter Lip Ht (in)	N/A	N/A	Gutter X Slope (%)	N/A
N/A	Painted X Walk1?	No	N/A	Painted X Walk2?	Yes
	X Walk 1 Direction	To S		X Walk 2 Direction	To E
N/A	X Walk 1 Width (in)	N/A	N/A	X Walk 2 Width (in)	111.0
	X Walk 1 Slope (%)	0.7		X Walk 2 Slope (%)	3.5
	X Walk 1 X Slope (%)	3.3		X Walk 2 X Slope (%)	6.5

N/A	Ramp inside XWalk1?	N/A	N/A	Ramp inside XWalk2?	Yes
	Road Slope (%)	2.4	N/A	Clear Space?	N/A
	Road X Slope (%)	9.3	N/A	Clear Space to XWalk (in)	N/A
N/A	Any Obstructions?	N/A	N/A	Storm Grate/Utility Hazard?	N/A
	Obstruction Type			Storm Grate/Utility Type	
		N/A			N/A
		Yes		Surface Condition? (G/P)	Good

Remove & Replace Curb Ramp With Two New Directional Ramps or Equivalent.

Total Cost: \$ 3200.00
