Access Compliance Report

Public Rights-of-Way

(Curb Ramps)

Intersection ID: 15242	Main Street: E_INDEPENDENCE_BV	Cross Street: N_WENDOVER_RD_RA	Location: SW
ADA ID: 2C2702BB26FF	Ramp Type: Perp	Initial Pass/Fail: Fail	Overall Compliance: No
Severity Score: 21.25			
Codes/Mitigation Info/Possible Solution		Field Measurements/Component Compliance

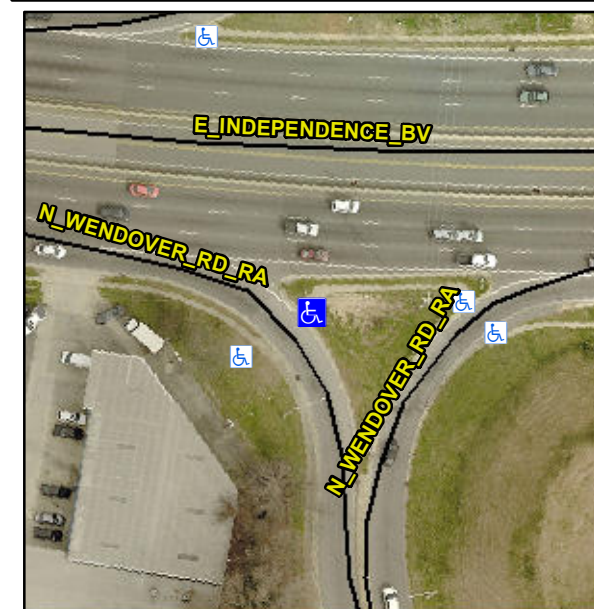
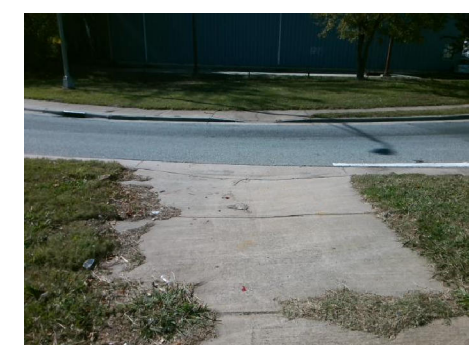
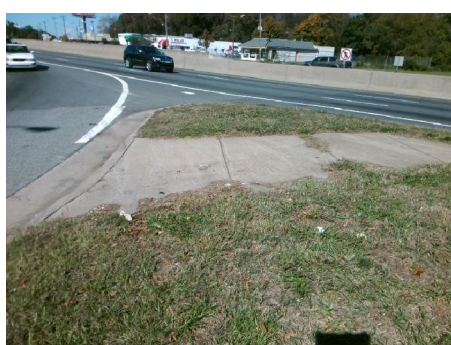
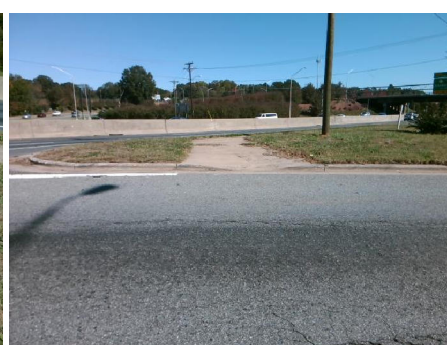
Not Found, R304.5.1, R304.2.2

Compliance	Description	Data	Compliance	Description	Data
N/A	Ramp Length (in)	65.0	No	Ramp Slope (%)	9.3
No	Ramp Width (in)	42.0	Yes	Ramp XSlope (%)	2.0
N/A	Flare Type LT	N/A	N/A	Flare Type RT	N/A
N/A	Flare Slope LT (%)	N/A	N/A	Flare Slope RT (%)	N/A
N/A	Flare Traversable LT?	N/A	N/A	Flare Traversable RT?	N/A
N/A	Landing Length (in)	N/A	N/A	DWS Provided?	N/A
N/A	Landing Width (in)	N/A	N/A	DWS Contrast?	N/A
N/A	Landing Slope (%)	N/A	N/A	DWS Length (in)	N/A
N/A	Landing X Slope (%)	N/A	N/A	DWS Full Width?	N/A
N/A	Landing Curb? (Y/N)	N/A	N/A	DWS Offset (in)	N/A
N/A	Shared Landing?	N/A			
N/A	Gutter Ponding?	N/A	N/A	Gutter Slope (%)	N/A
N/A	Gutter Lip Ht (in)	N/A	N/A	Gutter X Slope (%)	N/A
N/A	Painted X Walk1?	No	N/A	Painted X Walk2?	N/A
	X Walk 1 Direction	To S		X Walk 2 Direction	N/A
N/A	X Walk 1 Width (in)	N/A	N/A	X Walk 2 Width (in)	N/A
	X Walk 1 Slope (%)	6.3		X Walk 2 Slope (%)	N/A
	X Walk 1 X Slope (%)	1.8		X Walk 2 X Slope (%)	N/A

N/A	Ramp inside XWalk1?	N/A	N/A	Ramp inside XWalk2?	N/A
	Road Slope (%)	N/A	N/A	Clear Space?	N/A
	Road X Slope (%)	N/A	N/A	Clear Space to XWalk (in)	N/A
N/A	Any Obstructions?	N/A	N/A	Storm Grate/Utility Hazard?	N/A
	Obstruction Type			Storm Grate/Utility Type	
		N/A			N/A
			Yes	Surface Condition? (G/P)	Good

Remove & Replace Entire Ramp.
