Intersection ID: 50630	Main Street: TOM_SHORT_RD	Cross Street: CORAL_ROSE_RD	Location:	NW
ADA ID: 2C2750CC3D9A	Ramp Type: BlendTrans1	Initial Pass/Fail: Fail	Overall Compliance: No	Severity Score: 8.75

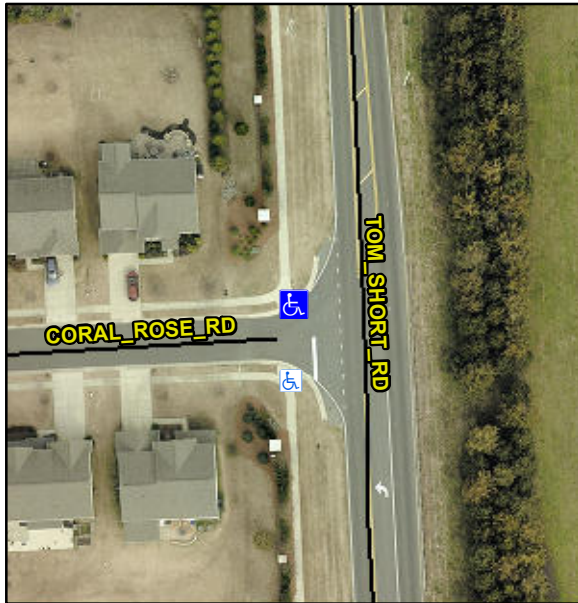
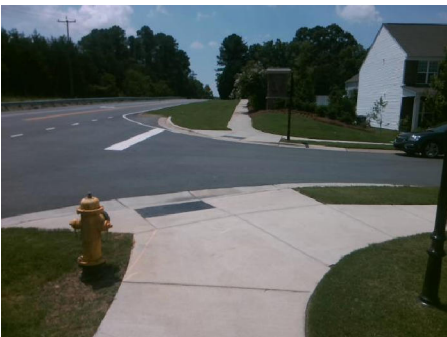
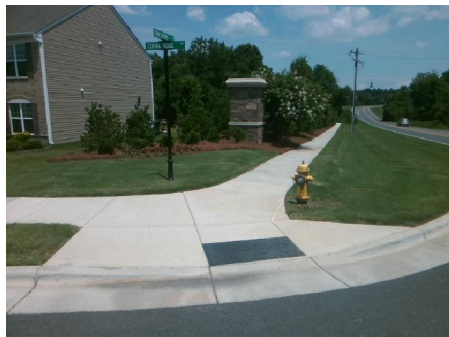
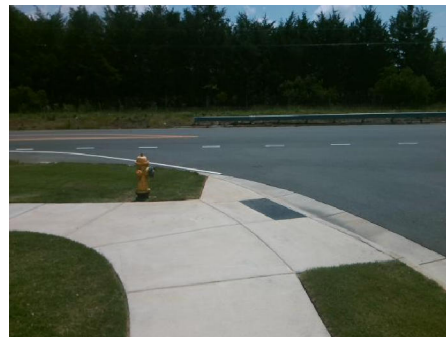
Not Found, R304.5.1

Compliance	Description	Data	Compliance	Description	Data
N/A	Ramp Length (in)	49.0	Yes	BlendTrans Slope (%)	3.1
No	Ramp Width (in)	46.0	Yes	BlendTrans XSlope (%)	0.9
N/A	Flare Type LT	N/A	N/A	Flare Type RT	N/A
N/A	Flare Slope LT (%)	N/A	N/A	Flare Slope RT (%)	N/A
N/A	Flare Traversable LT?	N/A	N/A	Flare Traversable RT?	N/A
N/A	Landing Length (in)	N/A	N/A	DWS Provided?	N/A
N/A	Landing Width (in)	N/A	N/A	DWS Contrast?	N/A
N/A	Landing Slope (%)	N/A	N/A	DWS Length (in)	N/A
N/A	Landing X Slope (%)	N/A	N/A	DWS Full Width?	N/A
N/A	Landing Curb? (Y/N)	N/A	N/A	DWS Offset (in)	N/A
N/A	Shared Landing?	N/A			
N/A	Gutter Ponding?	N/A	N/A	Gutter Slope (%)	N/A
N/A	Gutter Lip Ht (in)	N/A	N/A	Gutter X Slope (%)	N/A
N/A	Painted X Walk1?	No	N/A	Painted X Walk2?	No
	X Walk 1 Direction	To S		X Walk 2 Direction	To E
	X Walk 1 Width (in)	N/A		X Walk 2 Width (in)	N/A
	X Walk 1 Slope (%)	1.8		X Walk 2 Slope (%)	1.9
	X Walk 1 X Slope (%)	2.7		X Walk 2 X Slope (%)	3.0

N/A	Ramp inside XWalk1?	N/A	N/A	Ramp inside XWalk2?	N/A
	Road Slope (%)	0.3		Clear Space?	N/A
	Road X Slope (%)	3.8	N/A	Clear Space to XWalk (in)	N/A
N/A	Any Obstructions?	N/A	N/A	Storm Grate/Utility Hazard?	N/A
	Obstruction Type			Storm Grate/Utility Type	
		N/A			N/A
			Yes	Surface Condition? (G/P)	Good
			No	Curb Slope (%)	15.3

Remove & Replace Curb Ramp With Two New Directional Ramps or Equivalent.
