Access Compliance Report

Public Rights-of-Way

(Curb Ramps)

Intersection ID: 9373	Main Street: EUREKA_ST	Cross Street: GENESIS_PARK_PL	Location: NE
ADA ID: 2C29377FB449	Ramp Type: Perp	Initial Pass/Fail: Fail	Overall Compliance: No
		Severity Score: 12.5

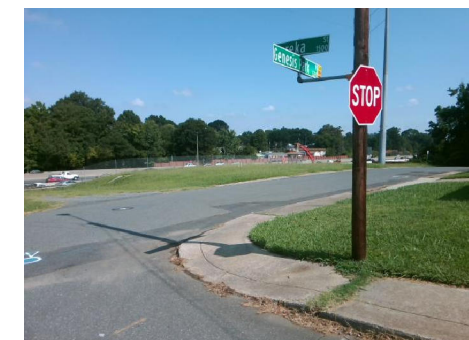
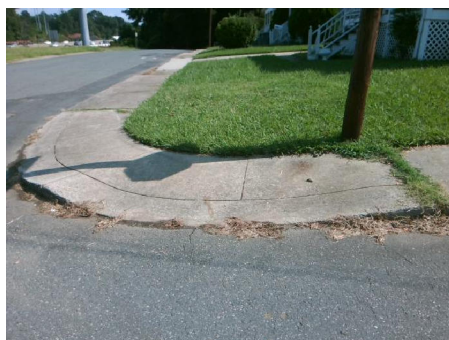
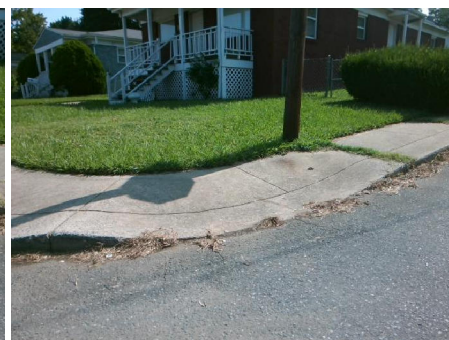
Compliance	Description	Data	Compliance	Description	Data
N/A	Ramp Length (in)	37.0	No	Ramp Slope (%)	11.5
Yes	Ramp Width (in)	60.0	Yes	Ramp XSlope (%)	1.2
N/A	Flare Type LT	N/A	N/A	Flare Type RT	N/A
N/A	Flare Slope LT (%)	N/A	N/A	Flare Slope RT (%)	N/A
N/A	Flare Traversable LT?	N/A	N/A	Flare Traversable RT?	N/A
N/A	Landing Length (in)	N/A	N/A	DWS Provided?	N/A
N/A	Landing Width (in)	N/A	N/A	DWS Contrast?	N/A
N/A	Landing Slope (%)	N/A	N/A	DWS Length (in)	N/A
N/A	Landing X Slope (%)	N/A	N/A	DWS Full Width?	N/A
N/A	Landing Curb? (Y/N)	N/A	N/A	DWS Offset (in)	N/A
N/A	Shared Landing?	N/A			
N/A	Gutter Ponding?	N/A	N/A	Gutter Slope (%)	N/A
N/A	Gutter Lip Ht (in)	0.5	N/A	Gutter X Slope (%)	N/A
N/A	Painted X Walk1?	No	N/A	Painted X Walk2?	N/A
	X Walk 1 Direction	To SW		X Walk 2 Direction	N/A
N/A	X Walk 1 Width (in)	N/A	N/A	X Walk 2 Width (in)	N/A
	X Walk 1 Slope (%)	1.1		X Walk 2 Slope (%)	N/A
	X Walk 1 X Slope (%)	2.8		X Walk 2 X Slope (%)	N/A

N/A	Ramp inside XWalk1?	N/A	N/A	Ramp inside XWalk2?	N/A
	Road Slope (%)	N/A	N/A	Clear Space?	N/A
	Road X Slope (%)	N/A	N/A	Clear Space to XWalk (in)	N/A
N/A	Any Obstructions?	N/A	N/A	Storm Grate/Utility Hazard?	N/A
	Obstruction Type			Storm Grate/Utility Type	
		N/A			N/A
			Yes	Surface Condition? (G/P)	Good

Remove & Replace Entire Ramp.
