Access Compliance Report

Public Rights-of-Way

(Curb Ramps)

Intersection ID: 27985	Main Street: FAIR_ISLE_DR	Cross Street: PROVIDENCE_RD_WEST	Location: NW
ADA ID: 2C2D023368B5	Ramp Type: Perp	Initial Pass/Fail: Fail	Overall Compliance: No
		Severity Score: 12.5

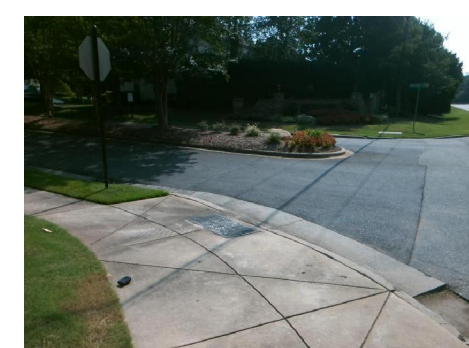
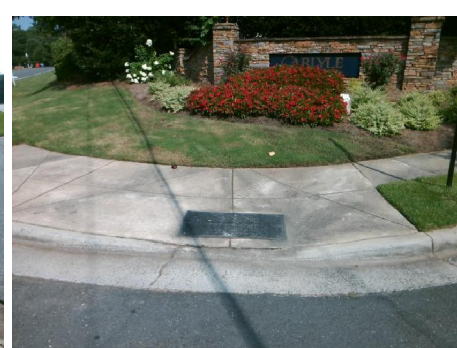
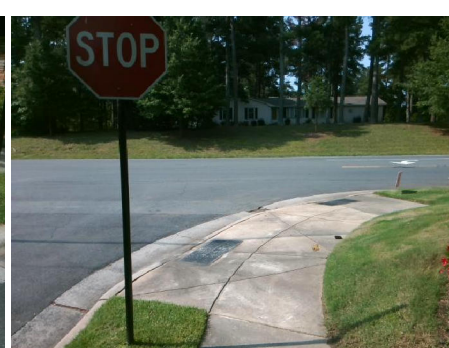
Possible Solutions:		Compliance	Description	Data
	Remove & Replace Entire Ramp.		No	Ramp Length (in)	97.0
			Yes	Ramp Width (in)	48.0
			N/A	Flare Type LT	N/A
			N/A	Flare Slope LT (%)	N/A
			N/A	Flare Traversable LT?	N/A
			N/A	Landing Length (in)	N/A
			N/A	Landing Width (in)	N/A
			N/A	Landing Slope (%)	N/A
			N/A	Landing X Slope (%)	N/A
<p>Surveyor Notes:</p> <p>N/A</p> <p>PROW/ADA:</p> <p>Not Found, R304.2.2</p>			N/A	Flare Type RT	N/A
			N/A	Flare Slope RT (%)	N/A
			N/A	Flare Traversable RT?	N/A
			N/A	DWS Provided?	N/A
			N/A	DWS Contrast?	N/A
			N/A	DWS Length (in)	N/A
			N/A	DWS Full Width?	N/A
			N/A	DWS Offset (in)	N/A
			N/A	Gutter Ponding?	N/A
			N/A	Gutter Lip Ht (in)	N/A
<p>Total Cost:</p> <p>\$ 1850.00</p>			No	Painted X Walk1?	N/A
			To E	X Walk 2 Direction	N/A
			N/A	X Walk 2 Width (in)	N/A

1.4	X Walk 2 Slope (%)	N/A
			1.8	X Walk 2 X Slope (%)	N/A
			N/A	Ramp inside XWalk1?	N/A
			N/A	Ramp inside XWalk2?	N/A
			N/A	Clear Space?	N/A
			N/A	Clear Space to XWalk (in)	N/A
			N/A	Storm Grate/Utility Hazard?	N/A
<p>Obstruction Type</p> <p>N/A</p>			N/A	Storm Grate/Utility Type	N/A
			N/A	Surface Condition? (G/P)	Good
