Access Compliance Report

Public Rights-of-Way

(Curb Ramps)

Intersection ID: 21994	Main Street: CREEKBED_LN	Cross Street: PARK_RD	Location: SW
ADA ID: 2C3227D8495F	Ramp Type: PerpDiag	Initial Pass/Fail: Fail	Overall Compliance: No
		Severity Score: 37.5

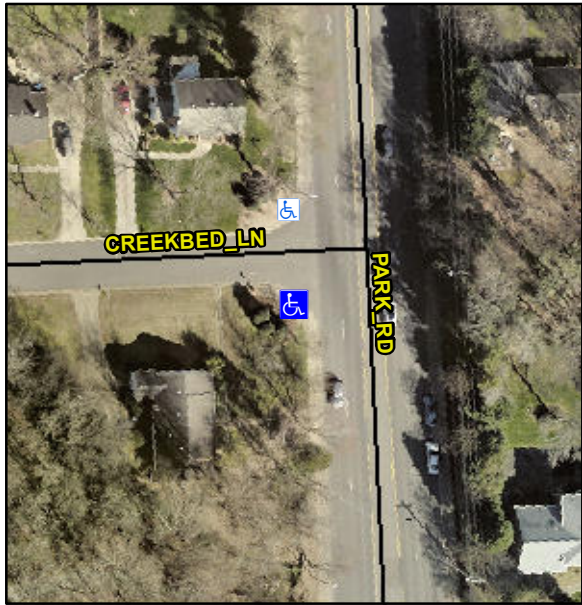
Possible Solutions:		Compliance	Description	Data	Compliance	Description	Data
	Remove & Replace Curb Ramp With Two New Directional Ramps or Equivalent.		N/A	Ramp Length (in)	60.0	No	Ramp Slope (%)	9.6
			Yes	Ramp Width (in)	48.0	No	Ramp XSlope (%)	9.3
			N/A	Flare Type LT	N/A	N/A	Flare Type RT	N/A
			N/A	Flare Slope LT (%)	N/A	N/A	Flare Slope RT (%)	N/A
			N/A	Flare Traversable LT?	N/A	N/A	Flare Traversable RT?	N/A
			N/A	Landing Length (in)	N/A	N/A	DWS Provided?	N/A
			N/A	Landing Width (in)	N/A	N/A	DWS Contrast?	N/A
			N/A	Landing Slope (%)	N/A	N/A	DWS Length (in)	N/A
			N/A	Landing X Slope (%)	N/A	N/A	DWS Full Width?	N/A
			N/A	Landing Curb? (Y/N)	N/A	N/A	DWS Offset (in)	N/A
			N/A	Shared Landing?	N/A			
			N/A	Gutter Ponding?	N/A	N/A	Gutter Slope (%)	N/A
			N/A	Gutter Lip Ht (in)	N/A	N/A	Gutter X Slope (%)	N/A

N/A	Painted X Walk1?	No	N/A	Painted X Walk2?	No
				X Walk 1 Direction	To E		X Walk 2 Direction	To N
			N/A	X Walk 1 Width (in)	N/A	N/A	X Walk 2 Width (in)	N/A
				X Walk 1 Slope (%)	6.0		X Walk 2 Slope (%)	1.0
				X Walk 1 X Slope (%)	0.5		X Walk 2 X Slope (%)	6.5
			N/A	Ramp inside XWalk1?	N/A	N/A	Ramp inside XWalk2?	N/A
			Road Slope (%)	6.9	N/A	Clear Space?	N/A	
			Road X Slope (%)	4.1	N/A	Clear Space to XWalk (in)	N/A	
		N/A	Any Obstructions?	N/A	N/A	Storm Grate/Utility Hazard?	N/A	
			Obstruction Type			Storm Grate/Utility Type		
					N/A		N/A	
					Yes	Surface Condition? (G/P)	Good
