# Access Compliance Report

## Public Rights-of-Way

### (Curb Ramps)

Intersection ID: 23151		Main Street: LAUREL_POINTE_WY		Cross Street: MOSS_RD		Location: SE			
ADA ID: 2C46D15F73B9		Ramp Type: Directional1		Initial Pass/Fail: Fail		Overall Compliance: No		Severity Score: 37.5	
Codes/Mitigation Info/Possible Solution					Field Measurements/Component Compliance

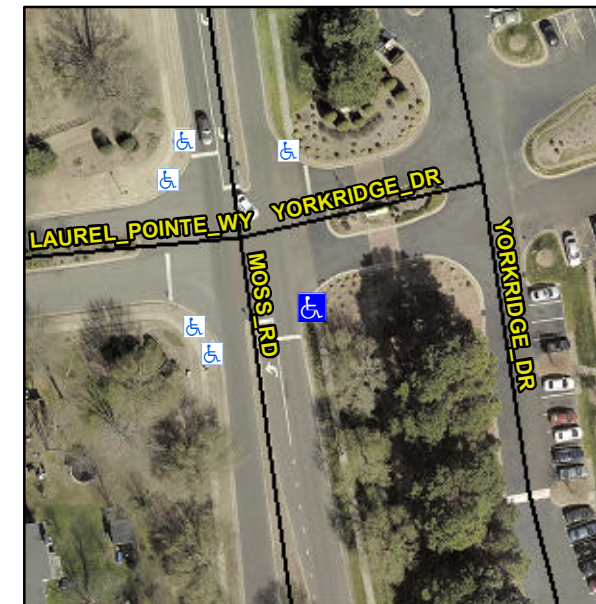
**R304.2.2, R304.5.3**

Compliance	Description	Data	Compliance	Description	Data
N/A	Ramp Length (in)	57.0	N/A	Grade Break?	N/A
Yes	Ramp Width (in)	59.0	N/A	Grade Break Slope (%)	0.0
No	Ramp Slope (%)	10.6	N/A	Grade Break XSlope (%)	0.0
No	Ramp XSlope (%)	9.3			
N/A	Flare Type LT	N/A	N/A	Flare Type RT	N/A
N/A	Flare Slope LT (%)	N/A	N/A	Flare Slope RT (%)	0.0
N/A	Flare Traversable LT?	N/A	N/A	Flare Traversable RT?	N/A
N/A	Landing Length (in)	0.0	N/A	DWS Provided?	N/A
N/A	Landing Width (in)	0.0	N/A	DWS Contrast?	N/A
N/A	Landing Slope (%)	0.0	N/A	DWS Length (in)	N/A
N/A	Landing X Slope (%)	0.0	N/A	DWS Full Width?	N/A
N/A	Landing Curb? (Y/N)	N/A	N/A	DWS Offset LT (in)	N/A
N/A	Shared Landing?	N/A	N/A	DWS Offset RT (in)	N/A
N/A	Gutter Ponding?	0.0	N/A	Gutter Slope (%)	N/A
N/A	Gutter Lip Ht (in)	0.0	N/A	Gutter X Slope (%)	N/A
N/A	Painted X Walk1?	No		Road Slope (%)	1.6
	X Walk 1 Direction	To SW		Road X Slope (%)	1.4
	X Walk 1 Width (in)	N/A		Clear Space?	N/A

X Walk 1 Slope (%)	1.6	N/A	Clear Space to XWalk (in)	N/A
	X Walk 1 X Slope (%)	1.4	N/A	Storm Grate/Utility Hazard?	N/A
N/A	Ramp inside XWalk1?	N/A		Storm Grate/Utility Type	
N/A	Any Obstructions?	N/A			N/A
	Obstruction Type		Yes	Surface Condition? (G/P)	Good
			N/A	Curb Slope (%)	0.4

**Remove & Replace Entire Ramp.**
