Access Compliance Report

Public Rights-of-Way

(Curb Ramps)

Intersection ID: 8619	Main Street: HATERAS_AV	Cross Street: JENNINGS_ST	Location: SE
ADA ID: 2C487053C9E8	Ramp Type: Perp	Initial Pass/Fail: Fail	Overall Compliance: No
			Severity Score: 21.25

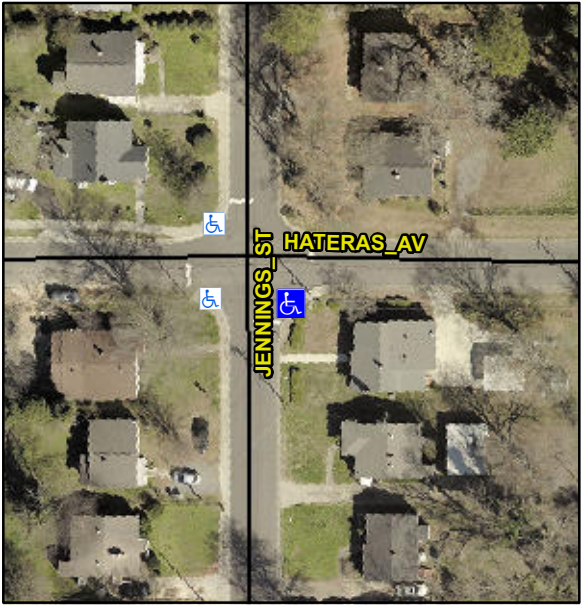
Possible Solutions:		Compliance	Description	Data
	Remove & Replace Entire Ramp.		N/A	Ramp Length (in)	46.0
			No	Ramp Width (in)	39.0
			N/A	Flare Type LT	N/A
			N/A	Flare Slope LT (%)	N/A
			N/A	Flare Traversable LT?	N/A
			N/A	Landing Length (in)	N/A
			N/A	Landing Width (in)	N/A
			N/A	Landing Slope (%)	N/A
			N/A	Landing X Slope (%)	N/A
<p>Surveyor Notes:</p> <p>N/A</p> <p>PROW/ADA:</p> <p>Not Found, R304.5.1, R304.2.2</p>			N/A	Flare Type RT	N/A
			N/A	Flare Slope RT (%)	N/A
			N/A	Flare Traversable RT?	N/A
			N/A	DWS Provided?	N/A
			N/A	DWS Contrast?	N/A
			N/A	DWS Length (in)	N/A
			N/A	DWS Full Width?	N/A
			N/A	DWS Offset (in)	N/A
			N/A	Shared Landing?	N/A
			N/A	Gutter Ponding?	N/A
			N/A	Gutter Lip Ht (in)	N/A
			N/A	Painted X Walk1?	No
				X Walk 1 Direction	To W
			N/A	X Walk 1 Width (in)	N/A
				X Walk 1 Slope (%)	1.3

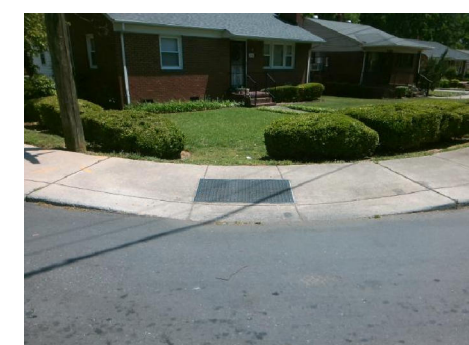
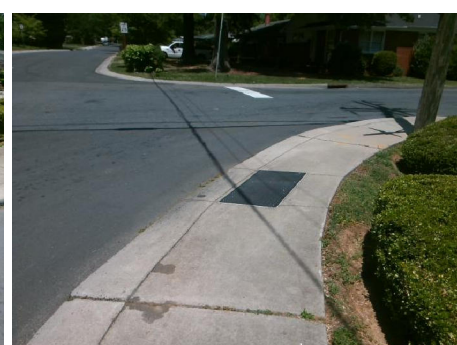
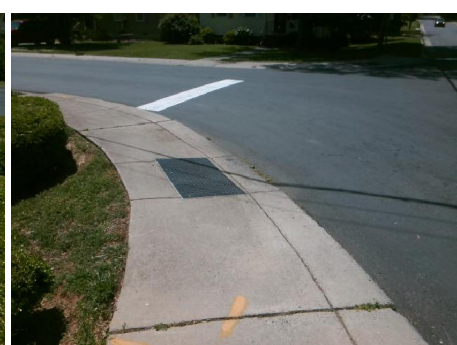
X Walk 1 X Slope (%)	1.8
			N/A	Ramp inside XWalk1?	N/A
			N/A	Road Slope (%)	N/A
			N/A	Road X Slope (%)	N/A
			N/A	Any Obstructions?	N/A
				Obstruction Type	
Total Cost:		\$ 1850.00			
			N/A		N/A
			Yes	Surface Condition? (G/P)	Good
