Access Compliance Report

Public Rights-of-Way

(Curb Ramps)

Intersection ID: 15322	Main Street: CRANBROOK_LN	Cross Street: RANDOLPH_RD	Location: NW
ADA ID: 2C4C61691D7B	Ramp Type: PerpDiag	Initial Pass/Fail: Fail	Overall Compliance: No
Severity Score: 50			
Codes/Mitigation Info/Possible Solution		Field Measurements/Component Compliance

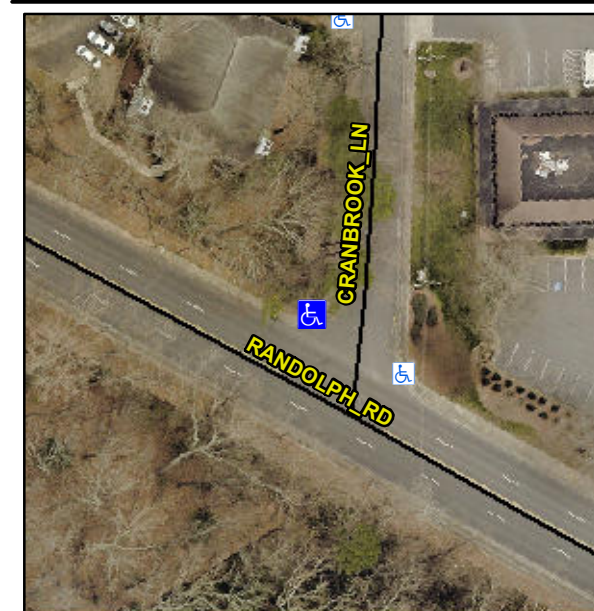
Not Found, R304.2.2, R304.5.3

Compliance	Description	Data	Compliance	Description	Data
N/A	Ramp Length (in)	50.0	No	Ramp Slope (%)	13.2
Yes	Ramp Width (in)	48.0	No	Ramp XSlope (%)	14.9
N/A	Flare Type LT	N/A	N/A	Flare Type RT	N/A
N/A	Flare Slope LT (%)	N/A	N/A	Flare Slope RT (%)	N/A
N/A	Flare Traversable LT?	N/A	N/A	Flare Traversable RT?	N/A
N/A	Landing Length (in)	N/A	N/A	DWS Provided?	N/A
N/A	Landing Width (in)	N/A	N/A	DWS Contrast?	N/A
N/A	Landing Slope (%)	N/A	N/A	DWS Length (in)	N/A
N/A	Landing X Slope (%)	N/A	N/A	DWS Full Width?	N/A
N/A	Landing Curb? (Y/N)	N/A	N/A	DWS Offset (in)	N/A
N/A	Shared Landing?	N/A			
N/A	Gutter Ponding?	N/A	N/A	Gutter Slope (%)	N/A
N/A	Gutter Lip Ht (in)	N/A	N/A	Gutter X Slope (%)	N/A
N/A	Painted X Walk1?	No	N/A	Painted X Walk2?	No
	X Walk 1 Direction	To SW		X Walk 2 Direction	To SE
N/A	X Walk 1 Width (in)	N/A	N/A	X Walk 2 Width (in)	N/A
	X Walk 1 Slope (%)	11.2		X Walk 2 Slope (%)	0.9
	X Walk 1 X Slope (%)	3.0		X Walk 2 X Slope (%)	11.0

N/A	Ramp inside XWalk1?	N/A	N/A	Ramp inside XWalk2?	N/A
	Road Slope (%)	10.8	N/A	Clear Space?	N/A
	Road X Slope (%)	3.9	N/A	Clear Space to XWalk (in)	N/A
N/A	Any Obstructions?	N/A	N/A	Storm Grate/Utility Hazard?	N/A
	Obstruction Type			Storm Grate/Utility Type	
		N/A			N/A
		Yes		Surface Condition? (G/P)	Good

Remove & Replace Curb Ramp With Two New Directional Ramps or Equivalent.
