Access Compliance Report

Public Rights-of-Way

(Curb Ramps)

Intersection ID: 12045	Main Street: HARLEE_AV	Cross Street: OLD_DOWD_RD	Location:	N
ADA ID: 2C51CB3F7DDF	Ramp Type: Perp	Initial Pass/Fail: Fail	Overall Compliance: No	Severity Score: 26.25

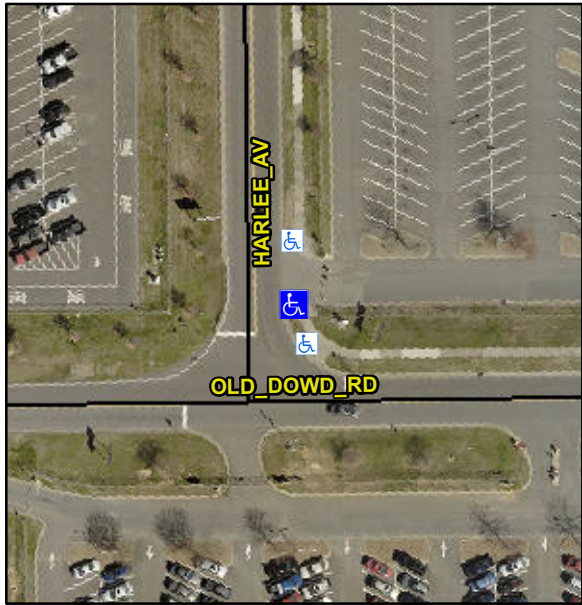
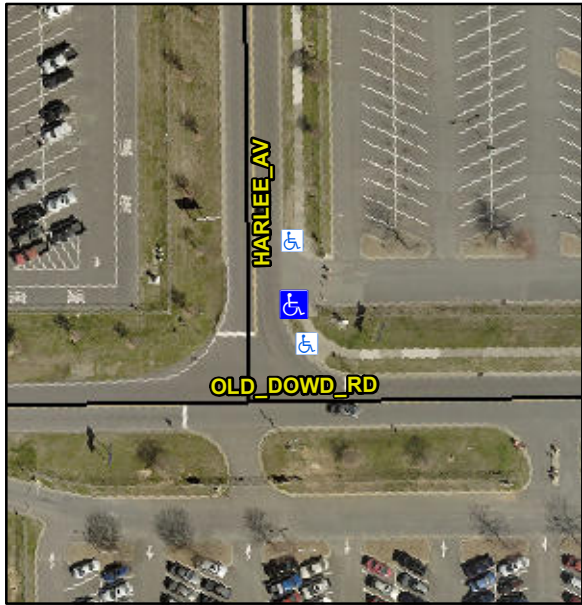
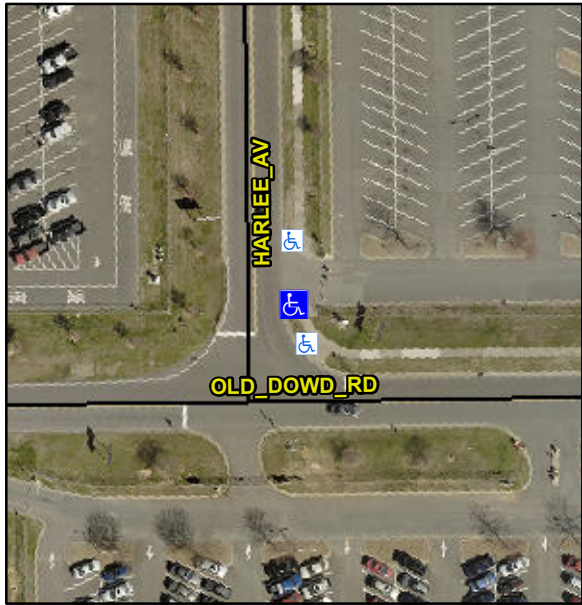
Possible Solutions:		Compliance	Description	Data	Compliance	Description	Data
	Remove & Replace Entire Ramp.		N/A	Ramp Length (in)	60.0	No	Ramp Slope (%)	12.3
			Yes	Ramp Width (in)	48.0	No	Ramp XSlope (%)	4.6
			N/A	Flare Type LT	N/A	N/A	Flare Type RT	N/A
			N/A	Flare Slope LT (%)	N/A	N/A	Flare Slope RT (%)	N/A
			N/A	Flare Traversable LT?	N/A	N/A	Flare Traversable RT?	N/A
			N/A	Landing Length (in)	N/A	N/A	DWS Provided?	N/A
			N/A	Landing Width (in)	N/A	N/A	DWS Contrast?	N/A
			N/A	Landing Slope (%)	N/A	N/A	DWS Length (in)	N/A
			N/A	Landing X Slope (%)	N/A	N/A	DWS Full Width?	N/A

X Walk 1 Direction	To N		X Walk 2 Direction	N/A
			N/A	X Walk 1 Width (in)	N/A	N/A	X Walk 2 Width (in)	N/A
				X Walk 1 Slope (%)	0.2		X Walk 2 Slope (%)	N/A
				X Walk 1 X Slope (%)	3.7		X Walk 2 X Slope (%)	N/A
			N/A	Ramp inside XWalk1?	N/A	N/A	Ramp inside XWalk2?	N/A

R304.2.2, R304.5.3

Remove & Replace Entire Ramp.
