Access Compliance Report

Public Rights-of-Way

(Curb Ramps)

Intersection ID: 14977	Main Street: BUCHANAN_ST	Cross Street: KENILWORTH_AV	Location: W
ADA ID: 2C553CB94928	Ramp Type: Perp	Initial Pass/Fail: Fail	Overall Compliance: No
			Severity Score: 26.25

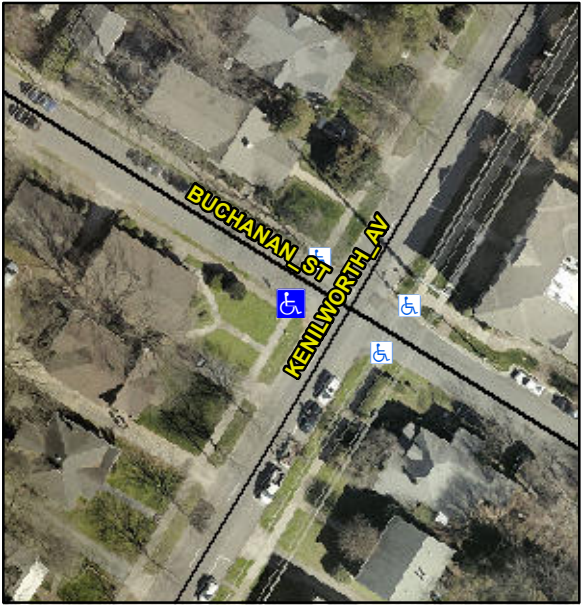
Possible Solutions:		Compliance	Description	Data
	Remove & Replace Entire Ramp.		N/A	Ramp Length (in)	31.0
			Yes	Ramp Width (in)	61.0
			N/A	Flare Type LT	N/A
			N/A	Flare Slope LT (%)	N/A
			N/A	Flare Traversable LT?	N/A
			N/A	Landing Length (in)	N/A
			N/A	Landing Width (in)	N/A
			N/A	Landing Slope (%)	N/A
			N/A	Landing X Slope (%)	N/A
<p>Surveyor Notes:</p> <p>N/A</p> <p>PROW/ADA:</p> <p>Not Found, R304.2.2, R304.5.3</p>			N/A	Flare Type RT	N/A
			N/A	Flare Slope RT (%)	N/A
			N/A	Flare Traversable RT?	N/A
			N/A	DWS Provided?	N/A
			N/A	DWS Contrast?	N/A
			N/A	DWS Length (in)	N/A
			N/A	DWS Full Width?	N/A
			N/A	DWS Offset (in)	N/A
			N/A	Shared Landing?	N/A
			N/A	Gutter Ponding?	N/A
			N/A	Gutter Lip Ht (in)	N/A
			N/A	Painted X Walk1?	No
				X Walk 1 Direction	To NE
			N/A	X Walk 1 Width (in)	N/A
				X Walk 1 Slope (%)	1.0

X Walk 1 X Slope (%)	0.5
			N/A	Ramp inside XWalk1?	N/A
				Road Slope (%)	N/A
				Road X Slope (%)	N/A
			N/A	Any Obstructions?	N/A
				Obstruction Type	
Total Cost:		\$ 1850.00			
			N/A		N/A
			Yes	Surface Condition? (G/P)	Good
