# Access Compliance Report

## Public Rights-of-Way

### (Curb Ramps)

Intersection ID: 44404	Main Street: FLOUFISHER_CT	Cross Street: BOBHOUSE_DR	Location:	SE
ADA ID: 2C56E9479324	Ramp Type: PerpDiag	Initial Pass/Fail: Fail	Overall Compliance: No	Severity Score: 30
Codes/Mitigation Info/Possible Solution		Field Measurements/Component Compliance

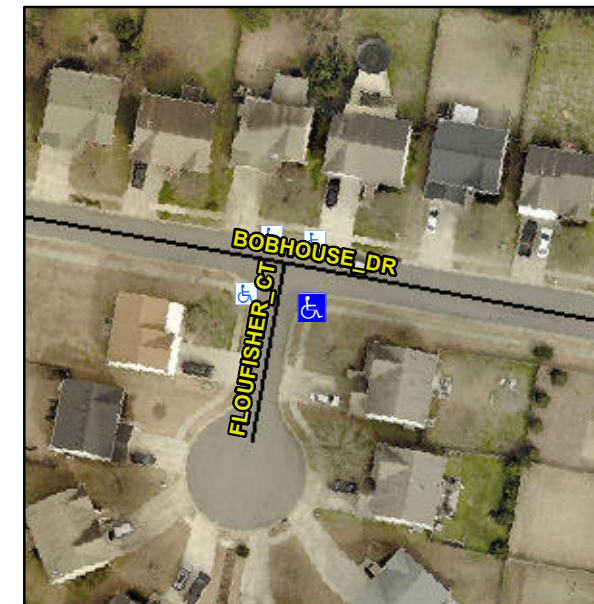
**Not Found, R304.5.1, R304.2.2**

Compliance	Description	Data	Compliance	Description	Data
N/A	Ramp Length (in)	49.0	No	Ramp Slope (%)	8.4
No	Ramp Width (in)	33.0	Yes	Ramp XSlope (%)	0.1
N/A	Flare Type LT	N/A	N/A	Flare Type RT	N/A
N/A	Flare Slope LT (%)	N/A	N/A	Flare Slope RT (%)	N/A
N/A	Flare Traversable LT?	N/A	N/A	Flare Traversable RT?	N/A
N/A	Landing Length (in)	N/A	N/A	DWS Provided?	N/A
N/A	Landing Width (in)	N/A	N/A	DWS Contrast?	N/A
N/A	Landing Slope (%)	N/A	N/A	DWS Length (in)	N/A
N/A	Landing X Slope (%)	N/A	N/A	DWS Full Width?	N/A
N/A	Landing Curb? (Y/N)	N/A	N/A	DWS Offset (in)	N/A
N/A	Shared Landing?	N/A			
N/A	Gutter Ponding?	N/A	N/A	Gutter Slope (%)	N/A
N/A	Gutter Lip Ht (in)	N/A	N/A	Gutter X Slope (%)	N/A
N/A	Painted X Walk1?	No	N/A	Painted X Walk2?	No
	X Walk 1 Direction	To NE		X Walk 2 Direction	To NW
N/A	X Walk 1 Width (in)	N/A	N/A	X Walk 2 Width (in)	N/A
	X Walk 1 Slope (%)	3.6		X Walk 2 Slope (%)	3.8
	X Walk 1 X Slope (%)	1.2		X Walk 2 X Slope (%)	2.5

N/A	Ramp inside XWalk1?	N/A	N/A	Ramp inside XWalk2?	N/A
	Road Slope (%)	0.3	N/A	Clear Space?	N/A
	Road X Slope (%)	4.6	N/A	Clear Space to XWalk (in)	N/A
N/A	Any Obstructions?	N/A	N/A	Storm Grate/Utility Hazard?	N/A
	Obstruction Type			Storm Grate/Utility Type	
		N/A			N/A
			Yes	Surface Condition? (G/P)	Good

**Remove & Replace Curb Ramp With Two New Directional Ramps or Equivalent.**

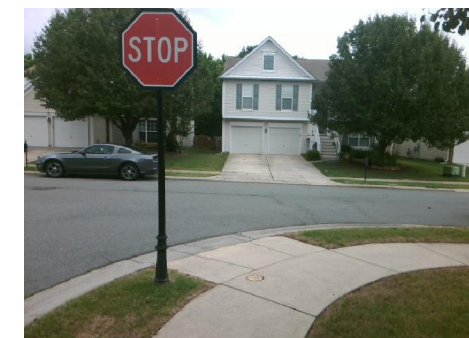
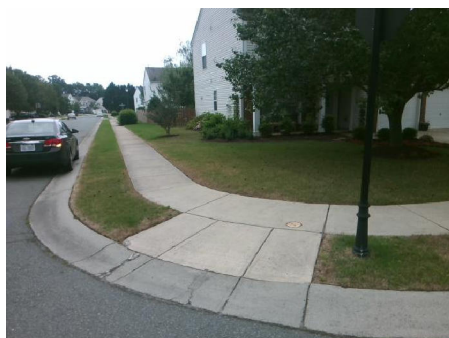
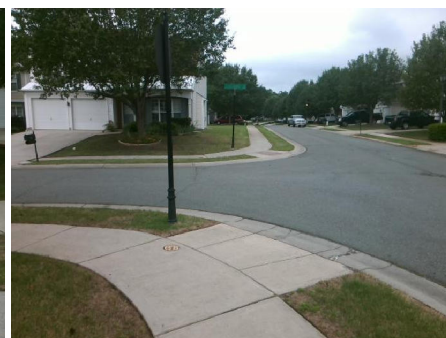
Street 1 Name **BOBHOUSE DR**  
 Stop Condition-Street 2 **None**  
 Street 2 Name **FLOUFISHER CT**  
 Stop Condition-Street 1 **StopSign**
